## Arlington County, Virginia Americans with Disabilities Act Evaluation Study

*Final Report*

August, 2012

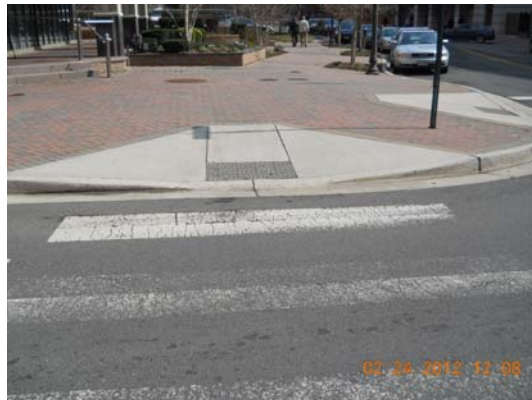
**Figure 1-3: Perpendicular Curb Ramps in Arlington, VA**

**Perpendicular Curb Ramps:** These ramps are generally perpendicular to the curb and lead pedestrians to travel perpendicular to vehicular traffic when entering the street. Perpendicular ramps should be installed with level landings at the top of the ramp to provide adequate space for users with limited mobility to move off the ramp before turning to proceed along the sidewalk (as shown in Figure 1-2). Figure 1-3 provides an example of a perpendicular ramp in Arlington.

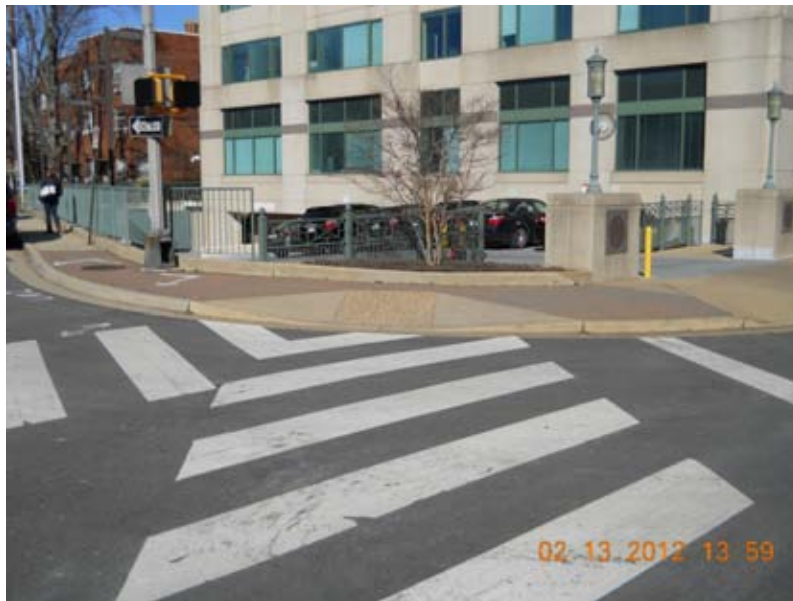
Figure 1-5: Diagonal Curb Ramp with Room to Maneuver Within the Crosswalk in Arlington, VA

**Diagonal Curb Ramps:** A diagonal curb ramp is a single ramp located at the apex of the corner of an intersection. The alignment of these ramps leads diagonally into the center of the intersection. These ramps are only appropriate if a level landing or maneuvering space is provided at the top *and bottom* of the ramp. Figure 1-4 provides an example of a diagonal curb ramp that provides a bottom landing within the crosswalk. This design allows individuals in wheelchairs to maneuver within the crosswalk, ideally outside of the path of traffic moving parallel to the desired crossing. Figure 1-5 provides an example of a diagonal curb ramp.

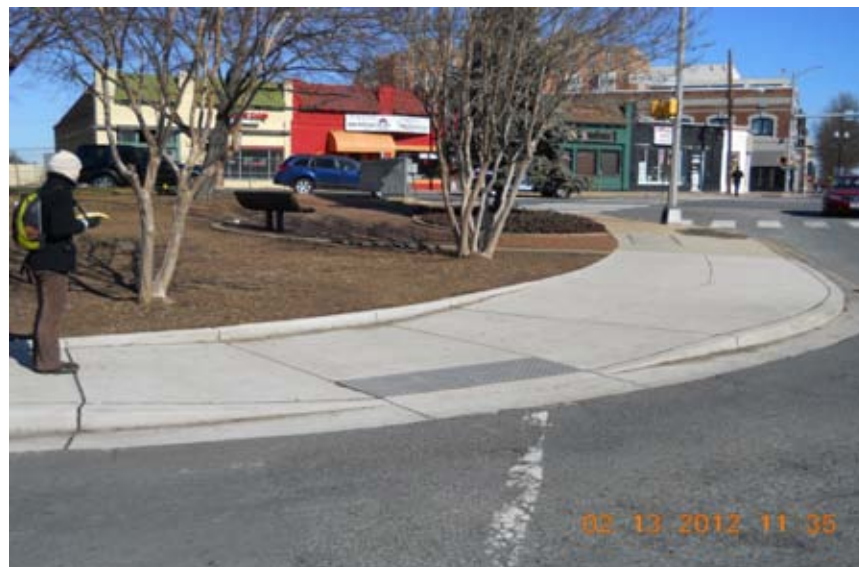
**Figure 1-6: A Parallel Curb Ramp at an Intersection in Arlington, VA**

**Parallel Curb Ramps:** A parallel curb ramp has two ramps leading down toward a level landing at the bottom between the ramps and level landings at the top of each ramp. These ramps are oriented so that the path of pedestrian travel on the ramp is parallel to vehicular traffic on the adjacent street. These ramps are frequently installed on narrow sidewalks where additional right-of-way is not available for landings. The landing at the bottom of parallel ramps is at street level, but must be sloped to prevent accumulation of water. Figure 1-6 provides an example of a parallel curb ramp.

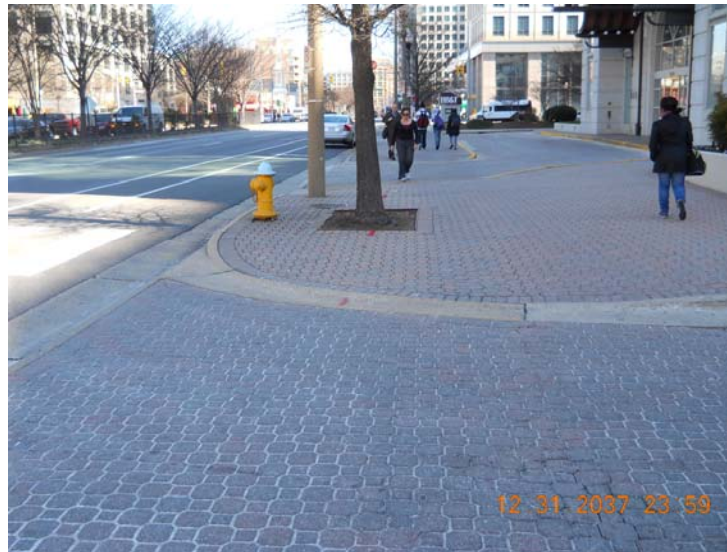
Figure 1-10: Example of Depressed Corner

**Depressed Corners:** Depressed corners gradually lower the level of the sidewalk to meet the grade of the street. They are often designed as an expanded diagonal curb ramp that extends around the entire corner of the intersection as shown in Figure 1-10.

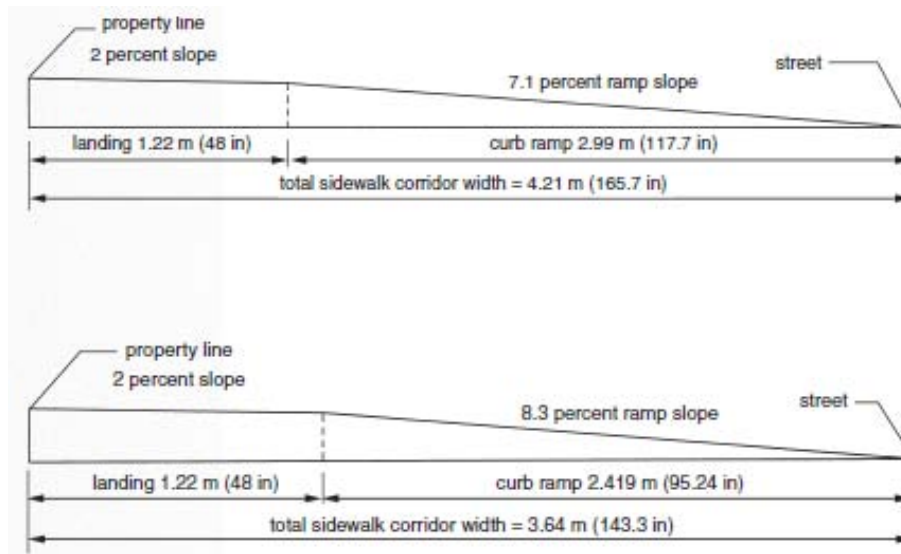
Figure 1-11: Ramp Profiles for Slopes of 7.1% and 8.3%

**Ramp Grade:** For new construction, the 2010 Standards permit a maximum curb ramp slope of 8.3%. In practice, 8.3% is frequently used as the design standard and does not allow for construction tolerances. Therefore, the FHWA recommends a grade of 7.1% to allow a construction tolerance. Figure 1-11 provides profiles of ramps with 7.1% and 8.3% slopes, respectively.

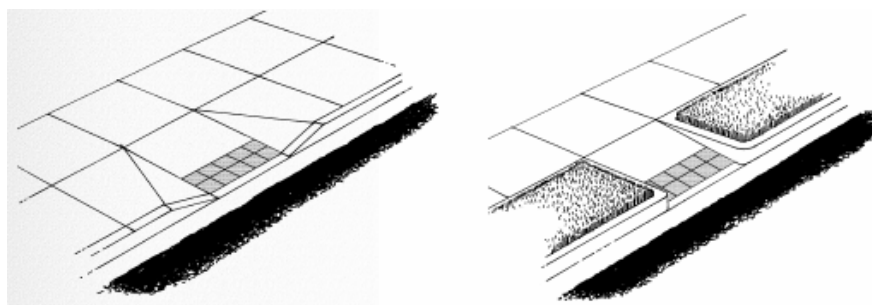
**Figure 1-13: Flares (left) and Returned Curbs Provide Transitions Between Sidewalks and Curb Ramps**

Returned curbs present a tripping hazard when pedestrians walk across the ramp. For this reason, returned curbs are only preferred when the curb ramp is located in a planting strip or the clear path of travel is not adjacent to the side of the ramp.

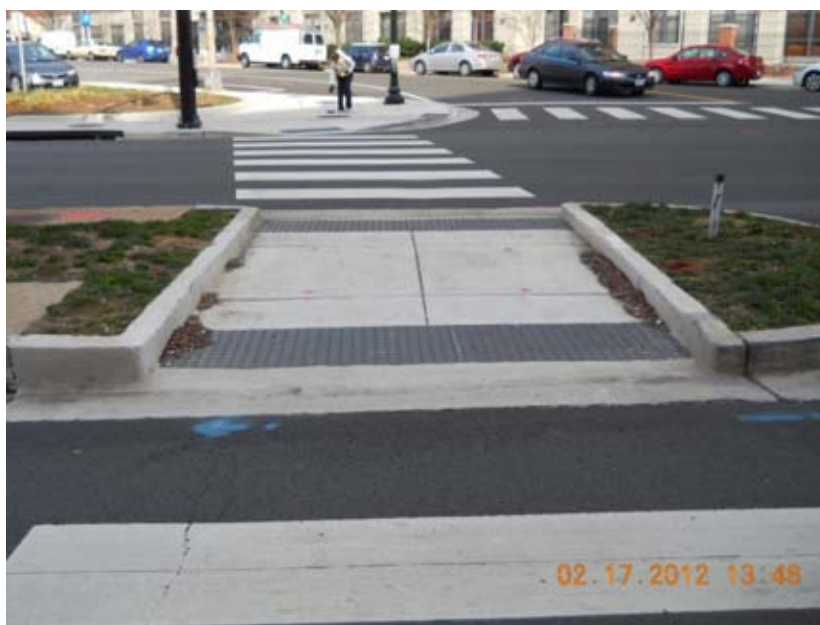
**Figure 1-16: Wide Median with Truncated Domes**

**Medians and Pedestrian Refuge Islands:** Medians are the portion of a divided roadway that separates vehicle traffic heading in opposite directions. Refuge islands are installed between the independent right turn lane (slip lane) and the normal intersection through lanes. Medians and refuge islands assist pedestrians by reducing crossing distance, providing a place of relative safety, and allowing pedestrians to focus on one direction of vehicle traffic at a time. Where applicable, medians and refuge islands should include ramps that do not exceed a slope of 8.3% (12:1). In addition, a level area with a width of 36 inches and length of 48 inches is required. The median should be at least 72 inches to provide adequate refuge for those in wheelchairs or those travelling with strollers or bicycles. Truncated domes should be placed to help identify the edge of the median for those with visual impairments. Figure 1-16 provides an example of a wide median with truncated domes.

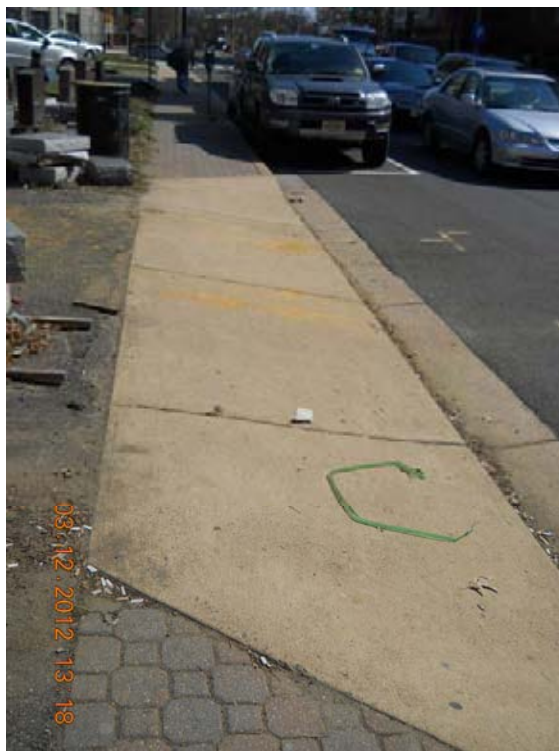
**Figure 1-20: Inaccessible Driveway Crossing with Severe Cross Slope**

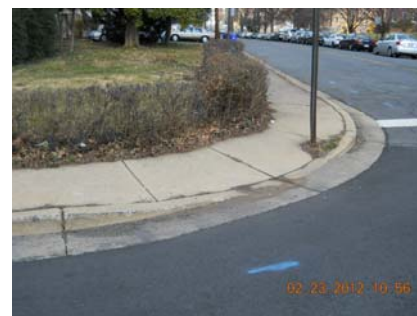
**Figure 2-3: Tier 1 Curb Ramp**

The classification Non-Compliant and Non-Functional represents the curb ramps that are not compliant with 2010 Standards and are not functional for a user with disabilities. These are the curb ramps that will require the most improvements to meet 2010 Standards. Given that they are non-functional for most limited-mobility users, they are recommended as a top priority for repair. Contributing attributes include obstructions that block access to the ramp or a ramp with a width less than 36 inches. Figure 2-3 shows a Tier 1 curb ramp that is obstructed by the pole of a street sign. From a total of 1,655 curb ramps within the study area, 40 are both Non-Compliant and Non-Functional. This represents 2.4% of all curb ramps surveyed.

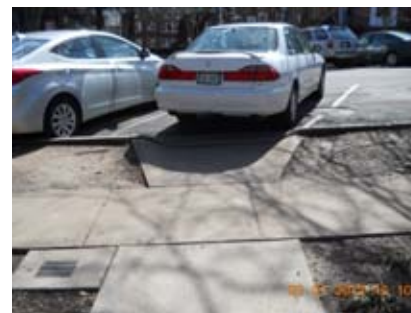
**Figure 2-4: Obstructed Curb Ramp**

**Curb Ramp Obstructions:** Obstructions block access to a ramp making it difficult or impossible to use. Possible obstructions include bollards, fire hydrants, newspaper boxes, utility covers, utility poles, street signs, vehicles, and poor or deteriorating physical conditions of the curb ramp. A total of 32 curb ramps representing 1.9% of all ramps were found with obstructions. A vehicle is seen obstructing a curb ramp in Figure 2-4.

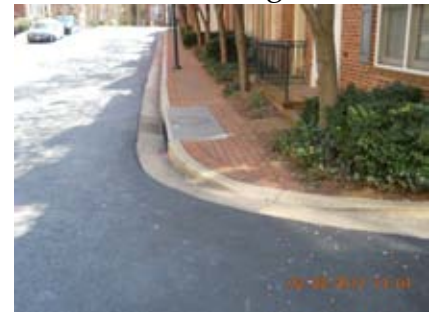
**Figure 2-5: Ramp is Obstructed and Below 36 Inches**

**Ramp Width is Less than 36 Inches:** A curb ramp with a width less than 36 inches is non-compliant under ADA guidelines and inaccessible for wheelchair users. Eight out of a total of 1,661 curb ramps (0.5%) were found to have widths less than 36 inches. Figure 2-5 shows a curb ramp with a width below 36 inches.

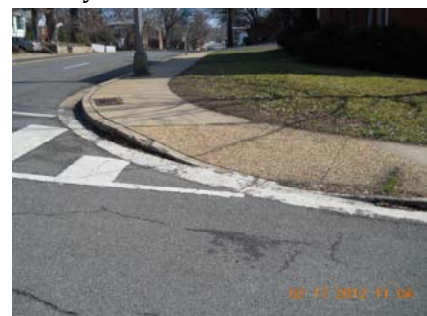
**Figure 2-6: Tier 2 Curb Ramp**

Given the large number of non-compliant but functional curb ramps, 1,442 out of 1,661 or 86.8%, and the diversity of conditions within this group, a rating system was used to separate these curb ramps into Tier 2 (many issues) and Tier 3 (fewer issues). Tier 2 contains curb ramps that netted an above average number of compliance issues in the rating system. Figure 2-6 pictures a Tier 2 curb ramp that does not meet slope requirements, lacks a landing and does not have 36 inches of bottom maneuvering space within the crosswalk. Tier 2 includes 742 out of 1,661 curb ramps or 44.7% of the curb ramps surveyed.

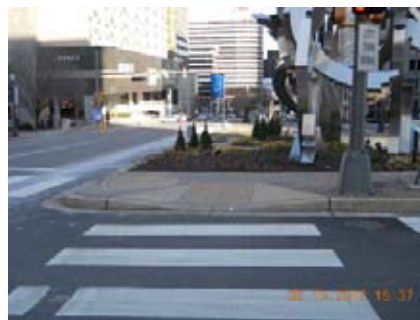
**Figure 2-7: Tier 3 Curb Ramp**

Tier 3 contains curb ramps with a below average number of compliance issues. While still non-compliant with 2010 Standards, these curb ramps have fewer issues than Tier 2 and are still considered functional for a majority of users. This tier represents 700 out of 1,661 curb ramps or 42.1% of the curb ramps surveyed. A Tier 3 curb ramp with some slope issues is shown in Figure 2-7.

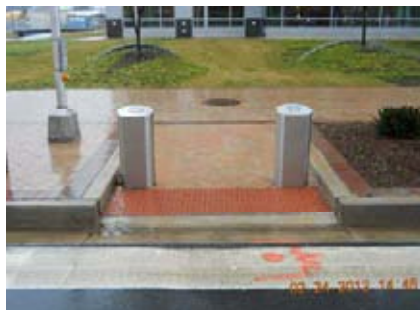
**Figure 2-8: Tier 4 Curb Ramp**

This tier represents curb ramps that meet all of the 2010 Standards (Figure 2-8). In addition, some exceptions are included where non-compliant or missing components do not hinder safe use of the curb ramp. For instance, if non-compliant flares do not impact the maneuvering space of people with disabilities, the slope of the flares is irrelevant. These exceptions are broken down into three different scenarios below. A total of 173 curb ramps, or 10.4% of all curb ramps, fell within the Tier 4 categorization.

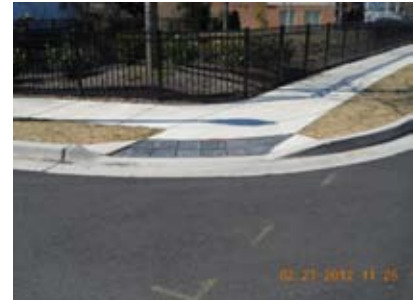
Figure 2-9: Non-Functional Flares

**Flare Exception:** When all other curb ramp components are compliant with 2010 Standards and the flares are not a functional component of the pathway. This exception was found at 140 curb ramps, or 8.4% of all ramps. Figure 2-9 pictures non-compliant, but irrelevant flares.

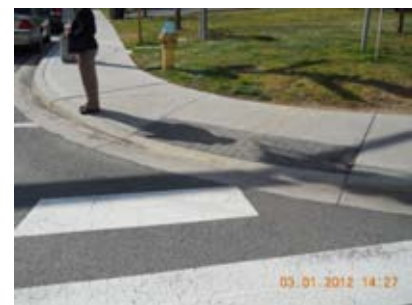
Figure 2-10: No Landing Needed

**Landing Exception:** When all other curb ramp components are compliant with 2010 Standards and no landing is necessary for wheelchair users to safely maneuver off of or past the curb ramp. In total, 23 curb ramps, or 1.4% of all ramps, were found with this exception. Figure 2-10 pictures a leveled crosswalk without a need for a landing.

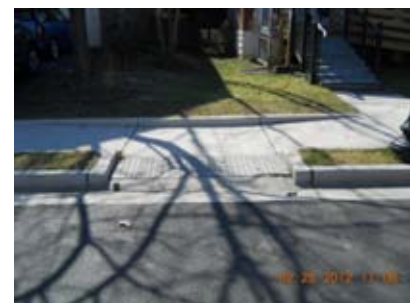
Figure 2-11: No Flares or Landing Needed

**Flare and Landing Exception:** Typically found on parallel curb ramps, when all other curb ramp components are compliant with 2010 Standards and no flares or landing is necessary to allow maneuverability. Eleven out of 1,661 curb ramps (0.1%) matched this exception. Figure 2-11 pictures a parallel curb ramp that does not have a need for flares or a landing to be functional.

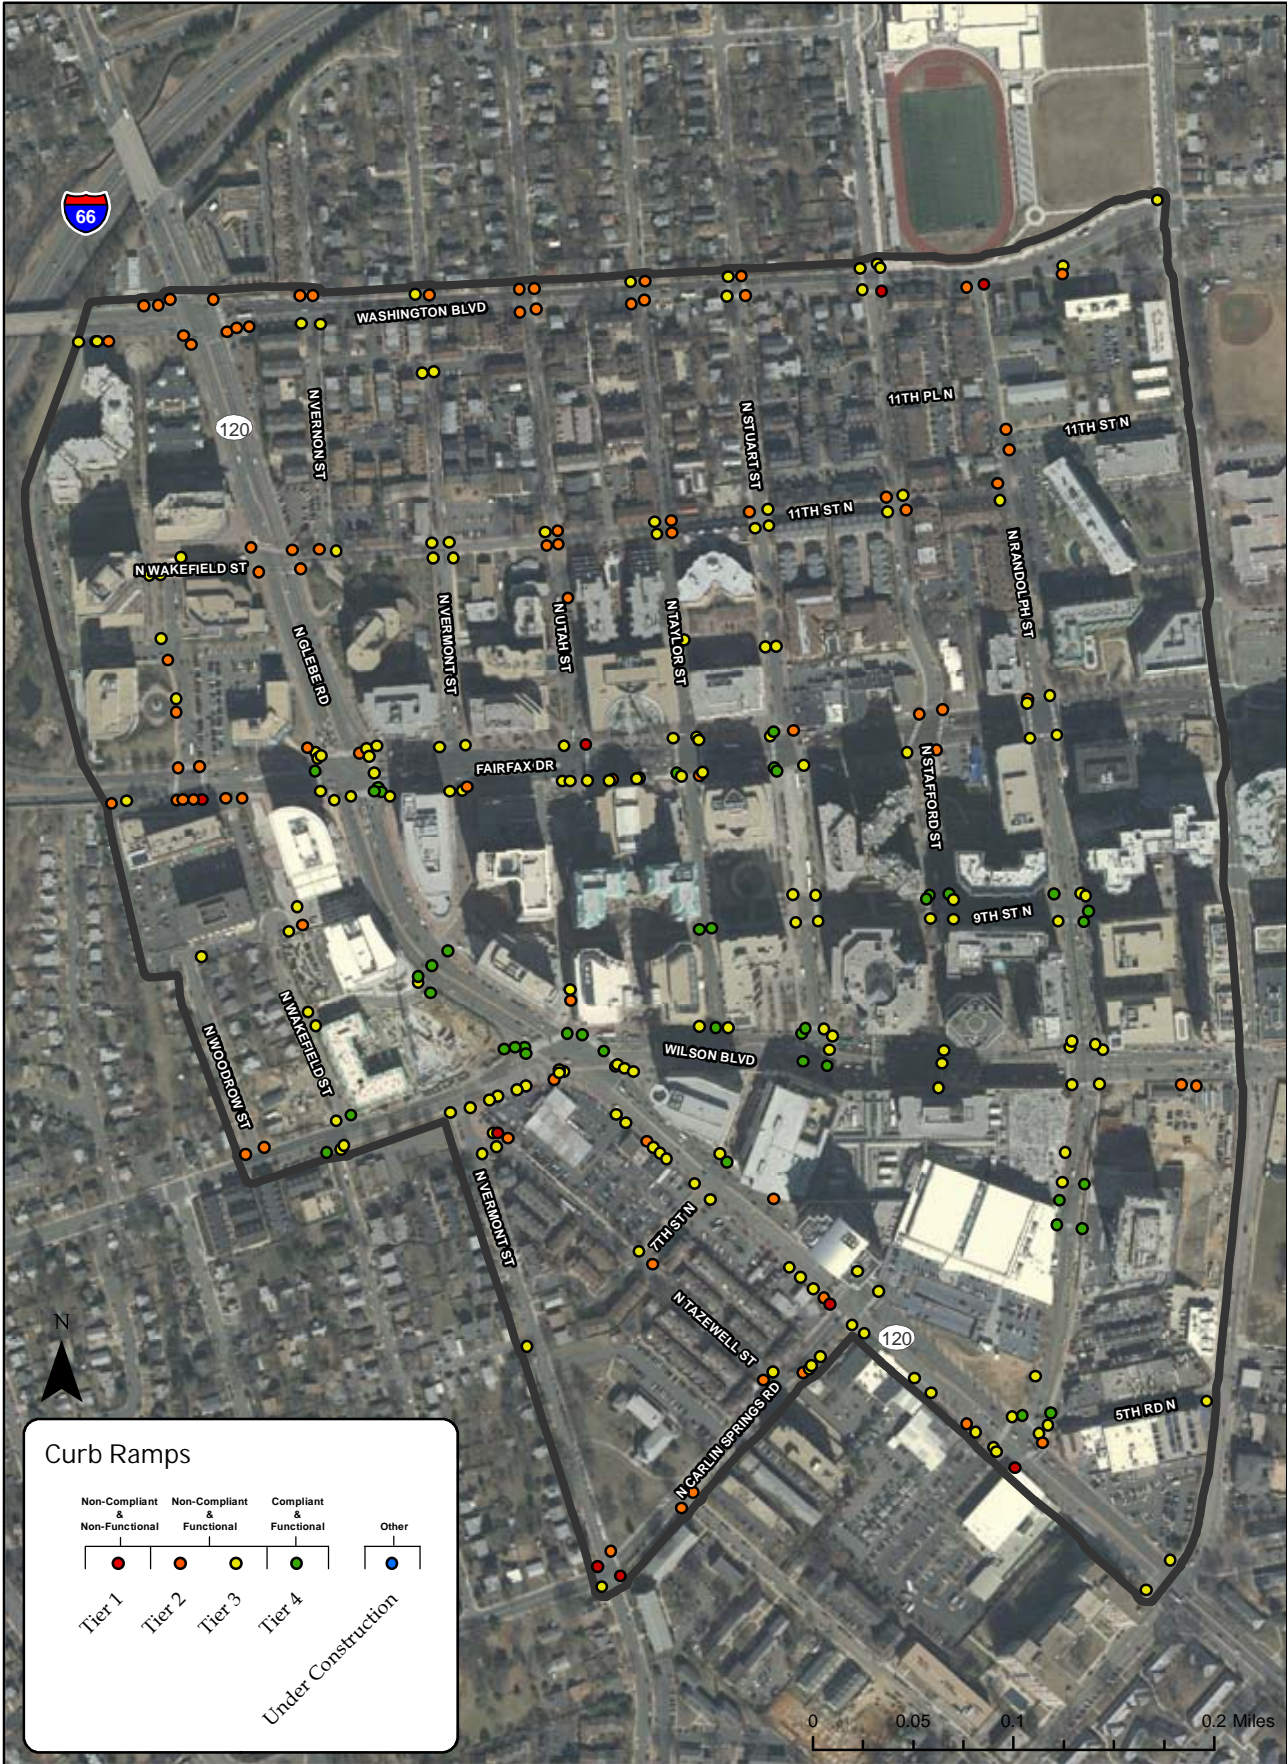
Figure 2-13: Ballston Curb Ramp Assessment Summary Map

The Ballston TOD is located in the westernmost region of the study area. Ballston is home to a number of high-rise office and residential towers. As seen in Figure 2-12, the majority of curb ramps within this TOD are above average condition, with 69.7% of curb ramps ranked in Tier 3 and Tier 4. Figure 2-13 is a map displaying the location of curb ramps within the Ballston TOD and the curb ramp tiered rating.

The heaviest concentration of Tier 4 curb ramps is close to the Ballston Commons Mall and the Ballston Metro Station. This area is framed by Fairfax Drive to the north, Randolph Street to the east, Wilson Boulevard to the south, and Glebe Road to the west.

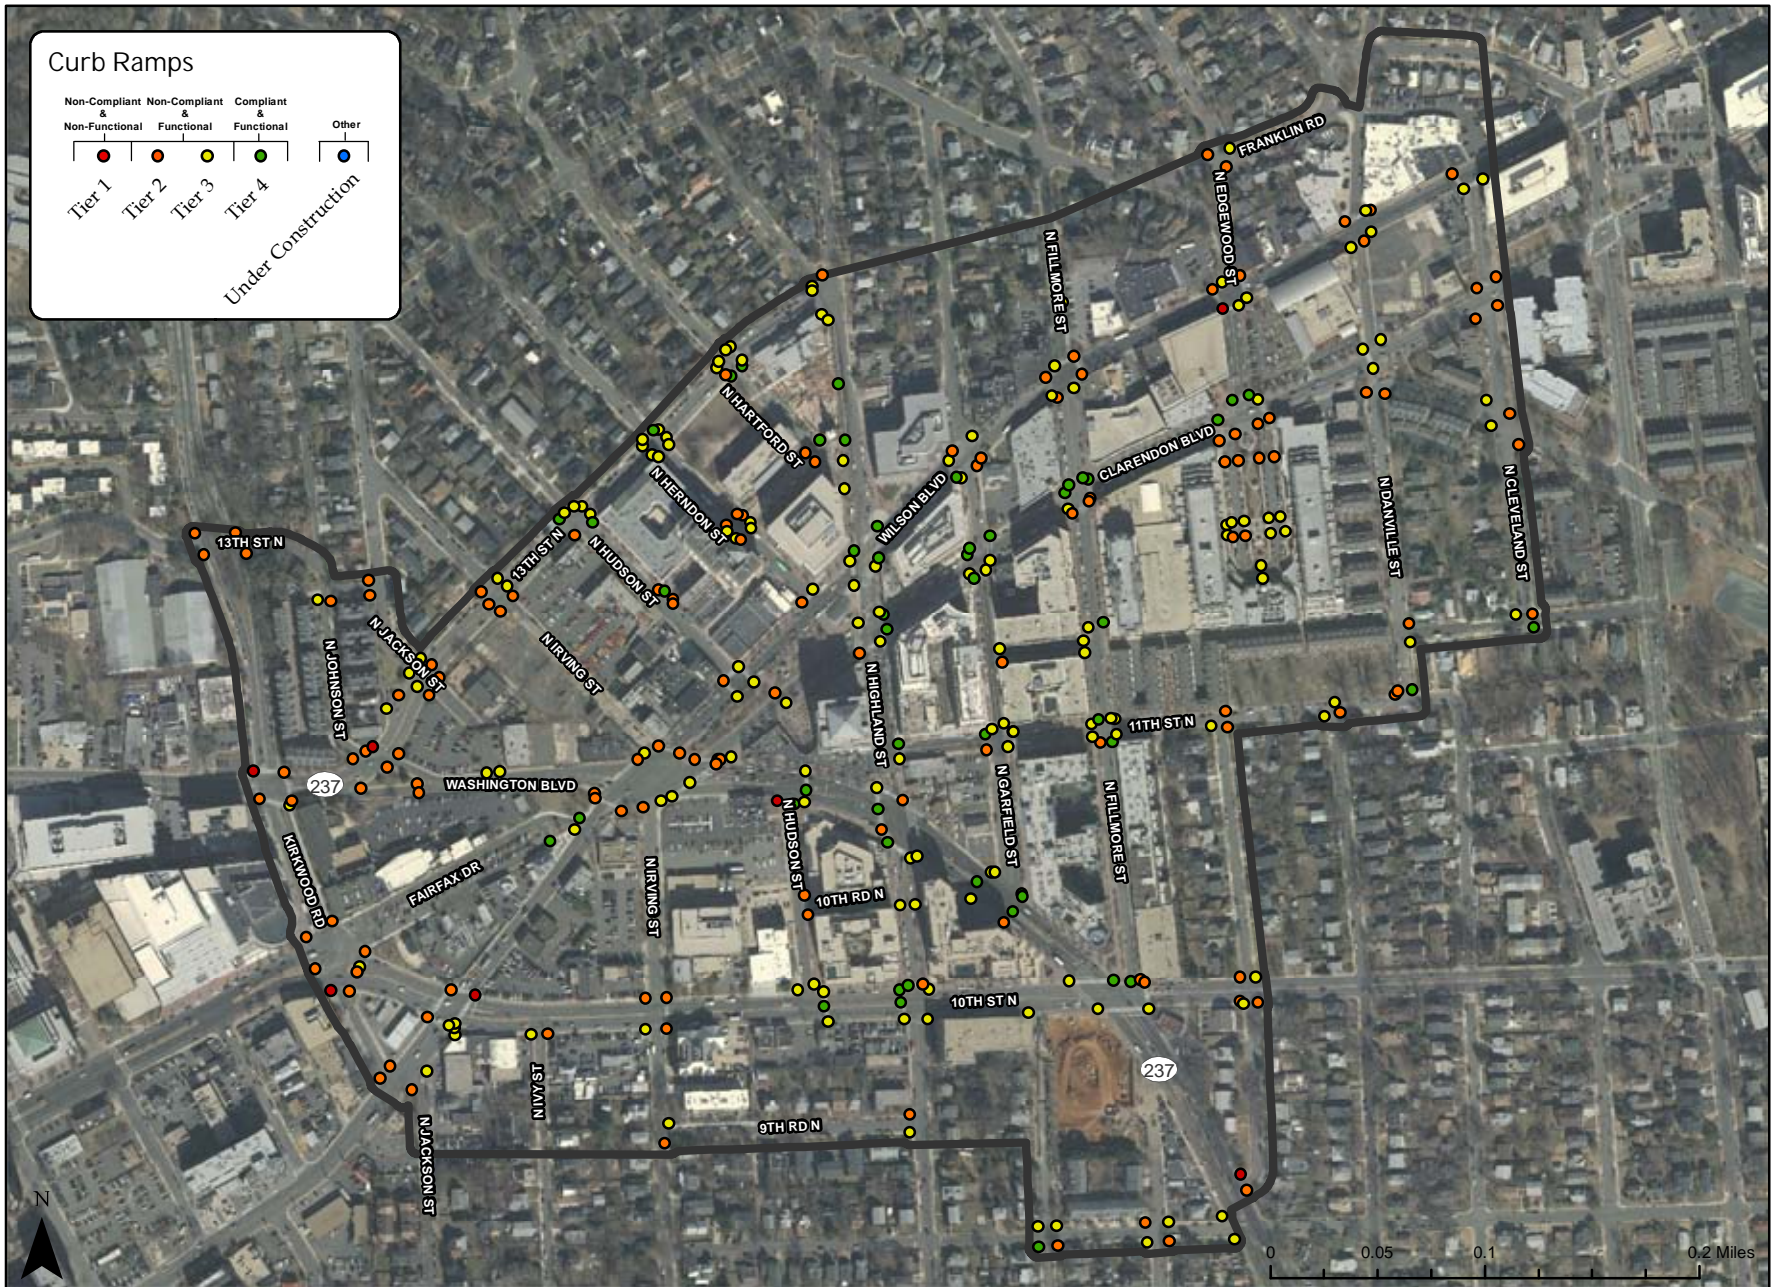
Figure 2-17: Clarendon Curb Ramp Assessment Summary Map

Located in the central portion of the study area, Clarendon is a heavily trafficked area with upscale restaurants and shopping. The major corridors through the TOD are Clarendon Boulevard, Wilson Boulevard, and Washington Boulevard. Clarendon features the largest proportion of Tier 4 curbside ramps among the TODs. As seen in Figure 2-16, the majority of curbside ramps within Clarendon are above average condition, with 56.9% of the curbside ramp inventory falling in the bottom tiers. Figure 2-17 is a map displaying the location of curbside ramps within the Clarendon TOD and the curbside ramp tiered rating.

Clarendon boasts the highest number and percentage of Tier 4 curbside ramps. The major groups include Clarendon Boulevard and areas close to the Clarendon Metro Station. The southern area of Clarendon also features a large number of Tier 4 curbside ramps.

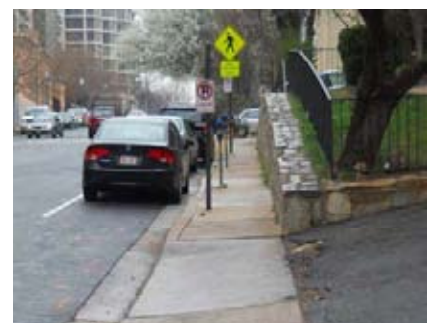
**Figure 2-25: Tier 1 Sidewalk Segment**

The Tier 1 categorization, Non-Compliant and Non-Functional, represents sidewalk segments that are most in need of improvements. They are not compliant with 2010 Standards and not functional for persons with mobility or visual impairments. This tier indicates a segment with a sidewalk that is less than 36 inches wide, doesn't continue for the entire length of the segment, or contains three or more obstructions (Figure 2-25). Out of

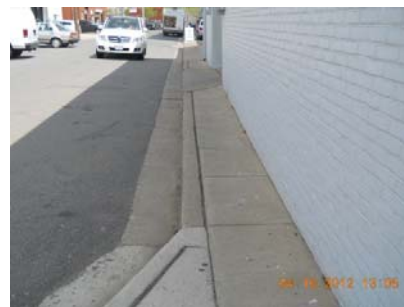
**Figure 2-26: Sidewalk Less Than 36\"**

**Sidewalk Segment Width Less than 36 Inches:** A sidewalk segment with a width less than 36 inches, as shown in Figure 2-26, is not only non-compliant, but also non-functional for persons who use wheelchairs. Only 15 sidewalk segments out of a total of 1,052 (1.4%) were found to have widths less than 36 inches.

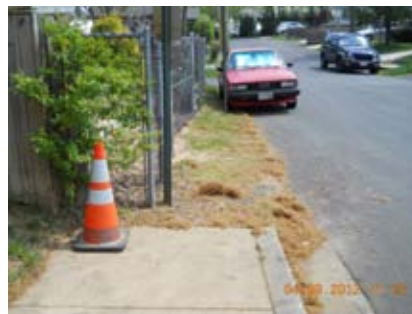
**Figure 2-27: Sidewalk Not Continuous**

**Sidewalk Not Continuous:** A sidewalk segment that is not continuous, as seen in Figure 2-27, is non-compliant and non-functional for persons with disabilities. The study area contained 54 pathways segments (5.1%) that were not continuous.

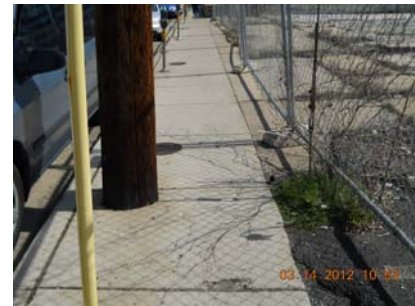
**Figure 2-28: Tier 2 Sidewalk Segment**

Sidewalk segments in Tier 2 are also non-compliant and non-functional, but have fewer compliance issues than Tier 1 sidewalks. Tier 2 (Figure 2-28) indicates a sidewalk segment that is at least 36 inches wide and continues for the entire length of the segment, but has one or two obstructions that render the segment non-compliant and non-functional for most limited-mobility users. A total of 160 sidewalk segments (15.2% of total) are categorized as Tier 2.

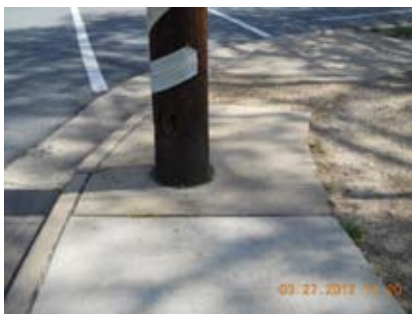
**Figure 2-29: Utility Pole as Obstruction**

**Sidewalk Obstructions:** Obstructions are objects that reduce the sidewalk to less than 36 inches, rendering the sidewalk unusable for those with mobility impairments. In the Arlington County study area, fixed obstructions include utility poles (Figure 2-29), street lights (Figure 2-30), traffic light poles, traffic sign poles, and fire hydrants (Figure 2-31). Severely uneven sidewalks or severe vertical elevation changes (Figure 2-32) are also considered fixed obstructions because they also impede accessibility. Moveable obstructions include trash cans and vehicles (Figure 2-33). Finally, landscaping (Figure 2-34) can also become an obstruction if it is not maintained. More than one out of five sidewalk segments (21.8%) were found to have two or less obstructions.

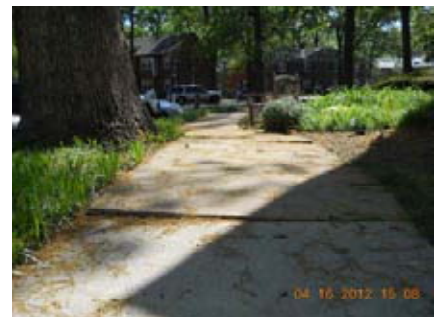
**Figure 2-35: Tier 3 Sidewalk Segment**

The Tier 3 categorization represents sidewalk segments that fall short of several 2010 Standards, but remain functional for most persons with limited mobility. This category includes sidewalk segments that contain cross-slope issues, running-slope issues, driveway slope issues, surface gaps, vertical changes, and protrusions. Tier 3 contains sidewalk segments that were found to have an above average number of these compliance issues. An example of a Tier 3 sidewalk segment is shown in Figure 2-35. A total of 217 sidewalk segments are classified as Tier 3, representing 20.6% of all sidewalk segments surveyed.

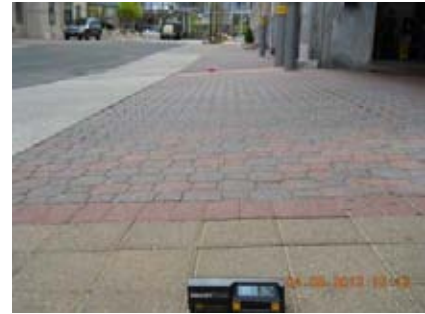
**Figure 2-36: Tier 4 Sidewalk Segment**

Sidewalk segments classified as Tier 4 are still non-compliant, but have fewer compliance issues (i.e., below average) than Tier 3 sidewalk segments. Hence, these segments are assumed to be generally more functional than Tier 3 segments for most users and are a slightly lower priority for repair or reconstruction. This category also includes sidewalk segments that contain cross-slope issues, running-slope issues, driveway slope issues, surface gaps, vertical changes, and/or protrusions. Figure 2-36 displays an example of a Tier 4 sidewalk with a cross slope issue. A total of 428 sidewalk segments are classified as Tier 4, representing 40.6% of all sidewalk segments surveyed within the study area.

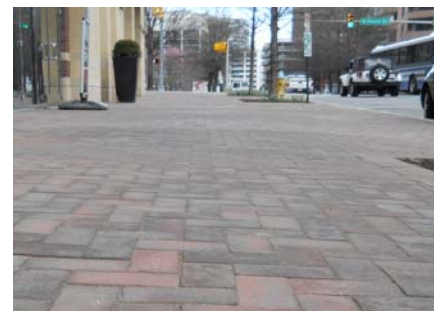
**Figure 2-37: Tier 5 Sidewalk Segment**

The category Compliant represents sidewalk segments that are completely compliant with the 2010 Standards. These sidewalk segments do not require any repair or reconstruction. Figure 2-37 shows an example of a compliant sidewalk segment. A total of 142 out of the 1,052 sidewalk segments (13.5%) in the study area are categorized as Tier 5.

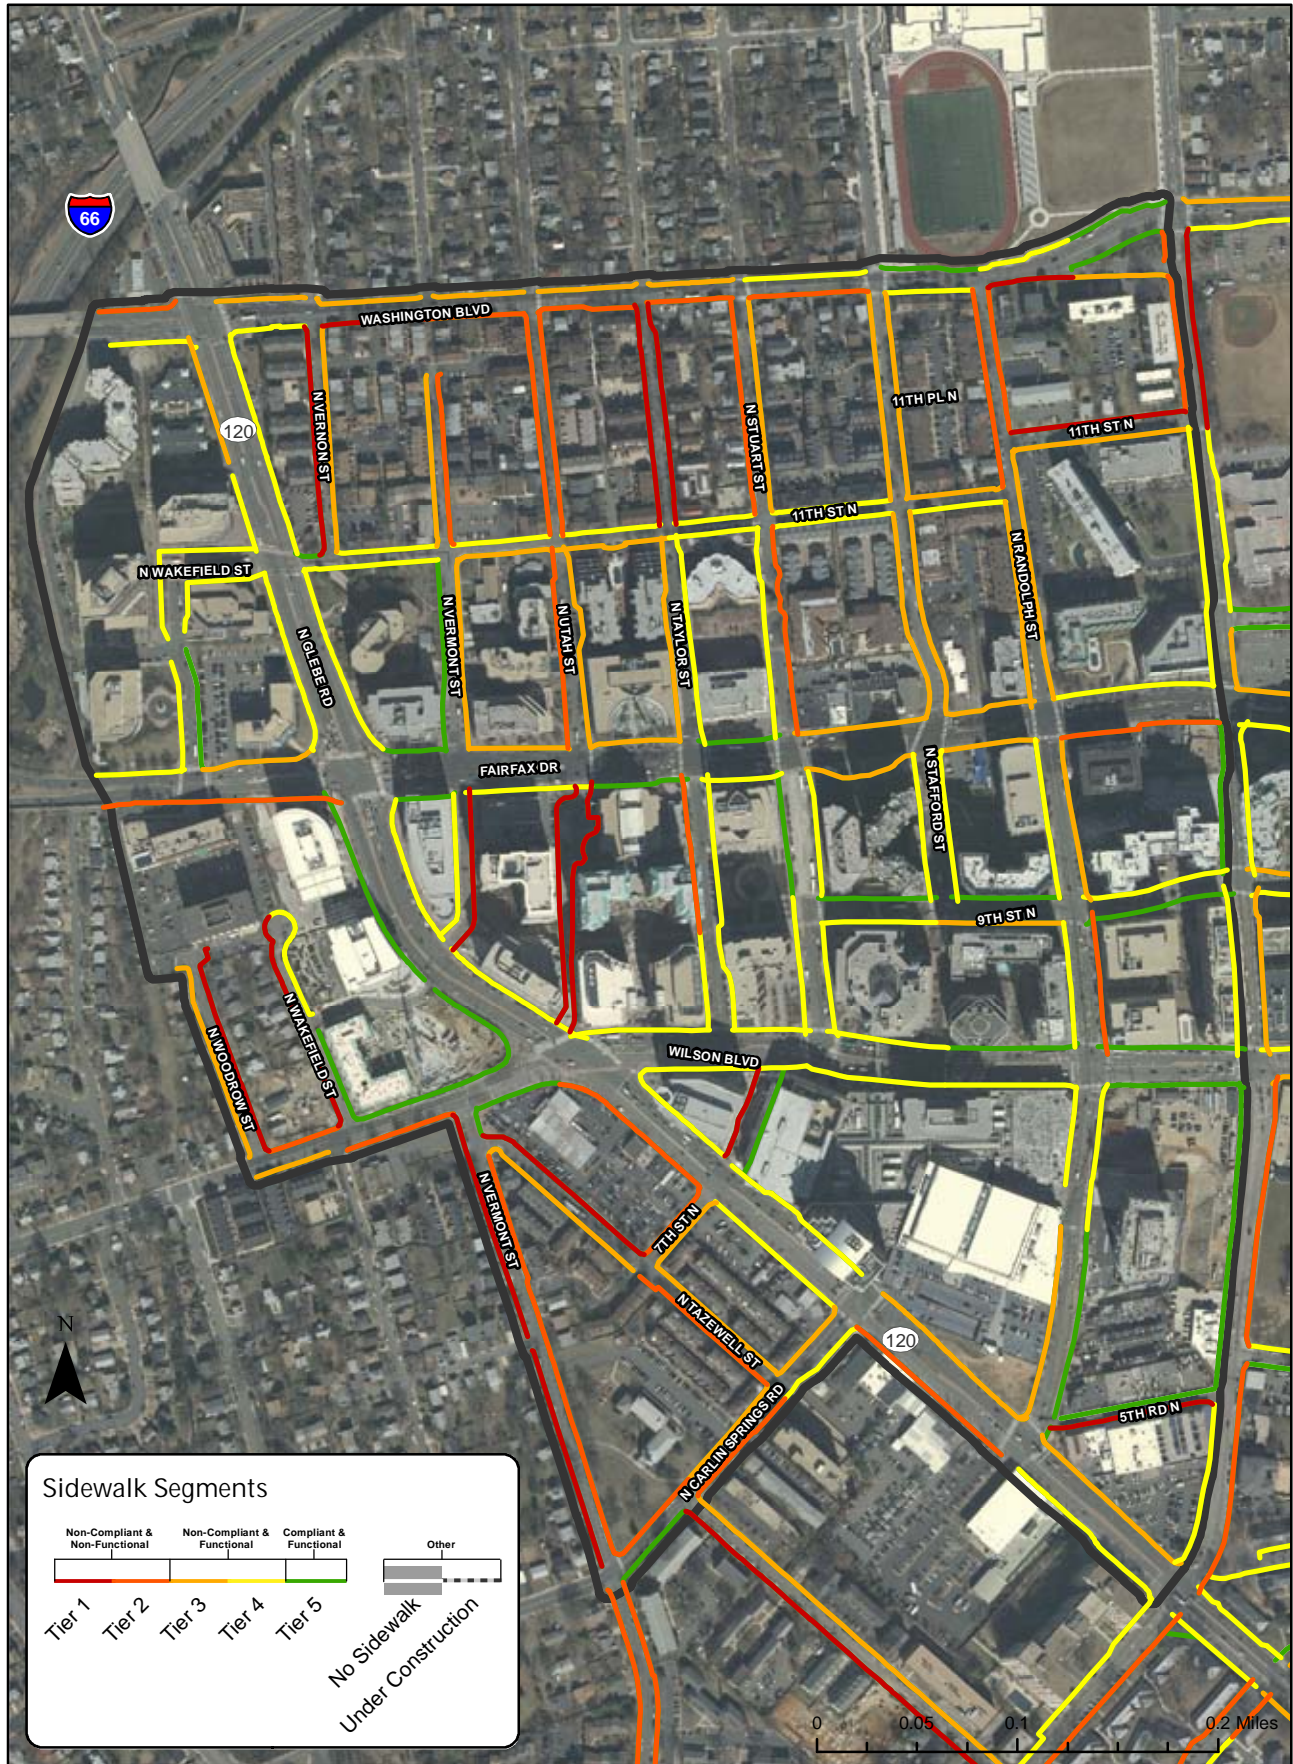
Figure 2-39: Ballston Sidewalk Assessment Summary Map

A map of sidewalk segment tiers for the Ballston TOD is displayed in Figure 2-39. Overall, the centrally located sidewalk segments have fewer compliance issues than those located on the outer edges of the TOD. With the exception of the sidewalk segments adjacent to Washington and Lee High School, the northern portion of the TOD contained segments that were classified as Tier 1, Tier 2, and Tier 3, with approximately half falling within the non-Compliant and non-Functional category. The southwest corner of Ballston is similarly lacking compliant and functional segments, with Tazewell Street, Vermont Street, and Carlin Springs Drive containing mostly sidewalk segments categorized as Tier 1 and Tier 2.

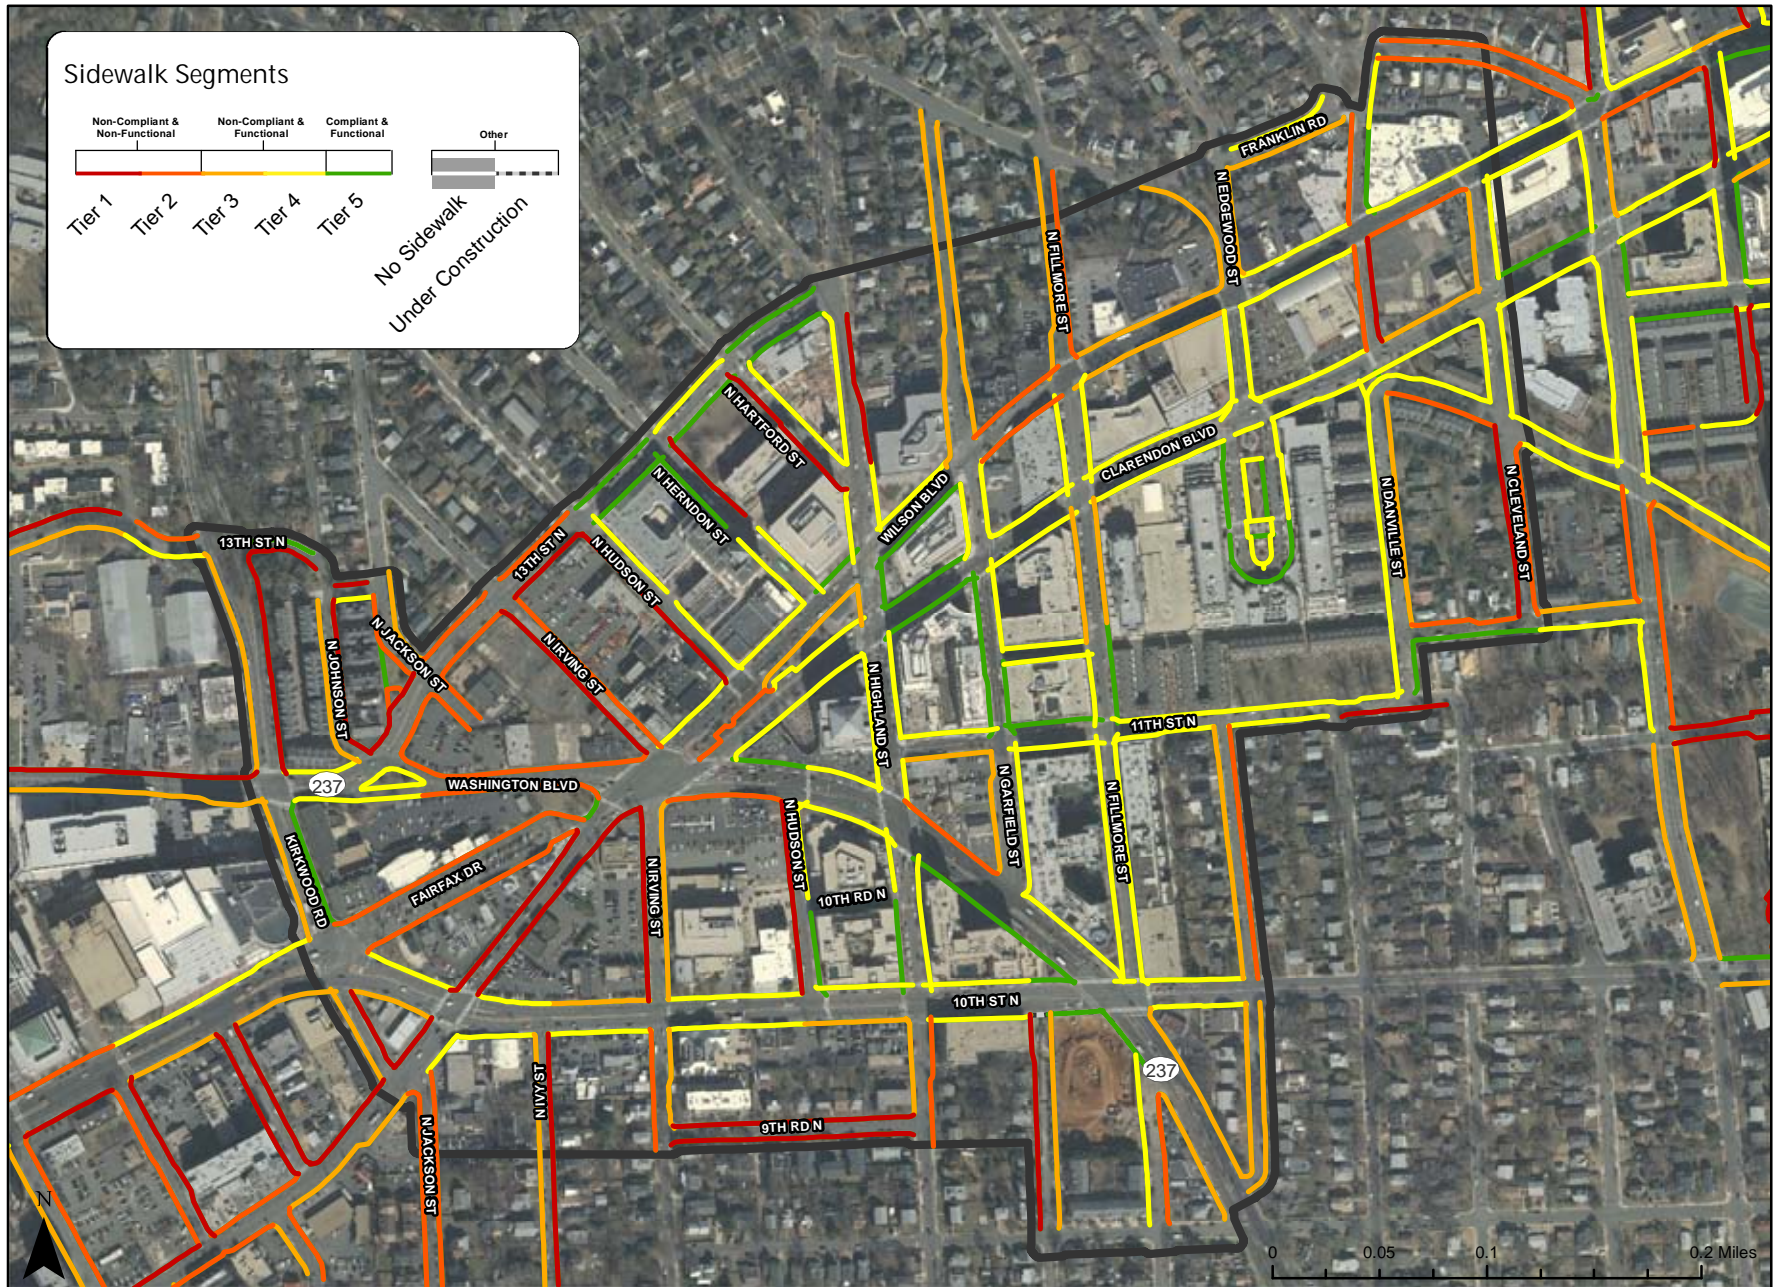
Figure 2-43: Clarendon Sidewalk Assessment Summary Map

A map of the sidewalk segment tiers for the Clarendon TOD is displayed in Figure 2-43. Most of the streets in the central and eastern portions of Clarendon are Tier 5, Compliant and Functional, or Tier 4, Non-Compliant but Functional.

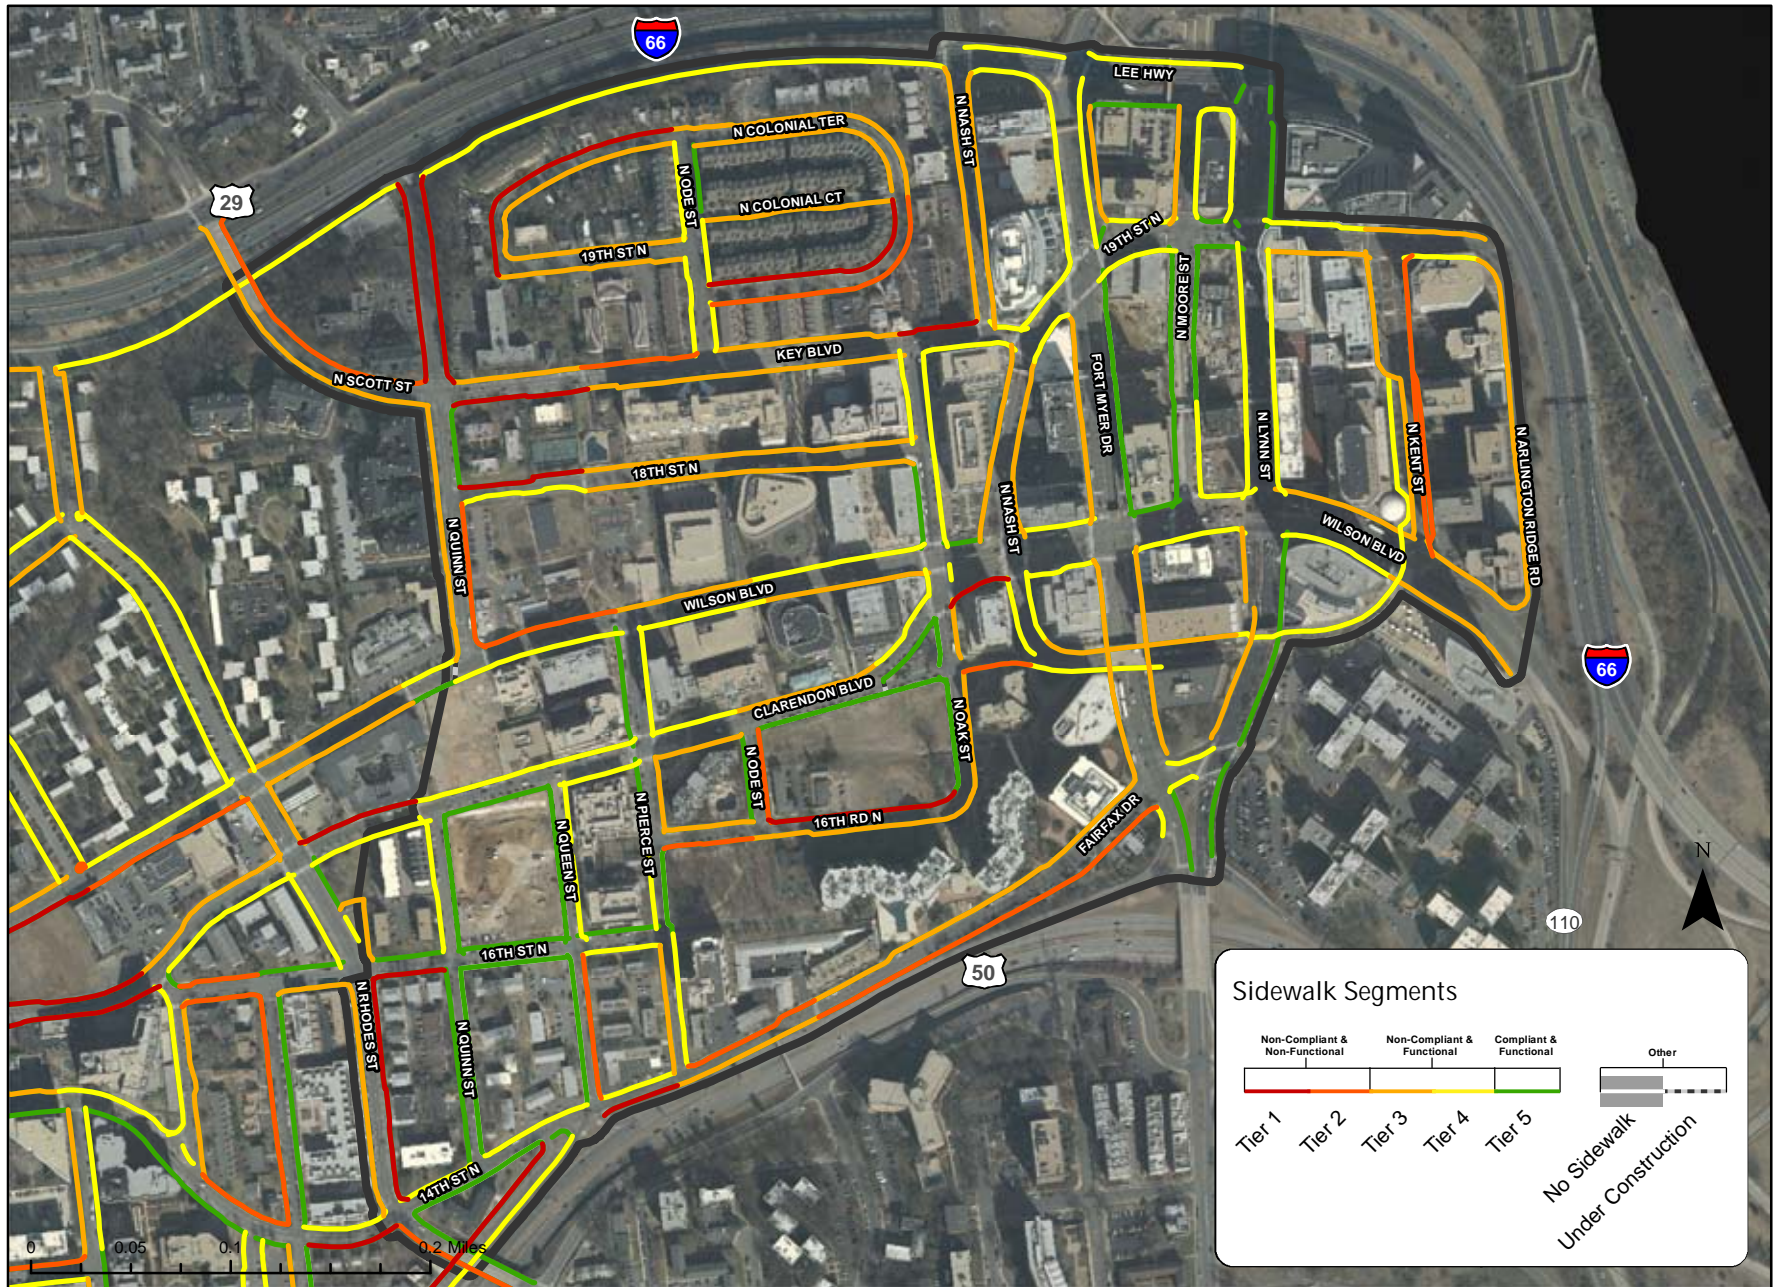
Figure 2-47: Rosslyn Sidewalk Assessment Summary Map

A map of the segments by tier for Rosslyn is displayed in Figure 2-47. The majority of the sidewalk segments within the northwestern quarter of the TOD fall into Tiers 1, 2, and 3.
