## Arlington County, Virginia Americans with Disabilities Act Evaluation Study

*Final Report*

August, 2012

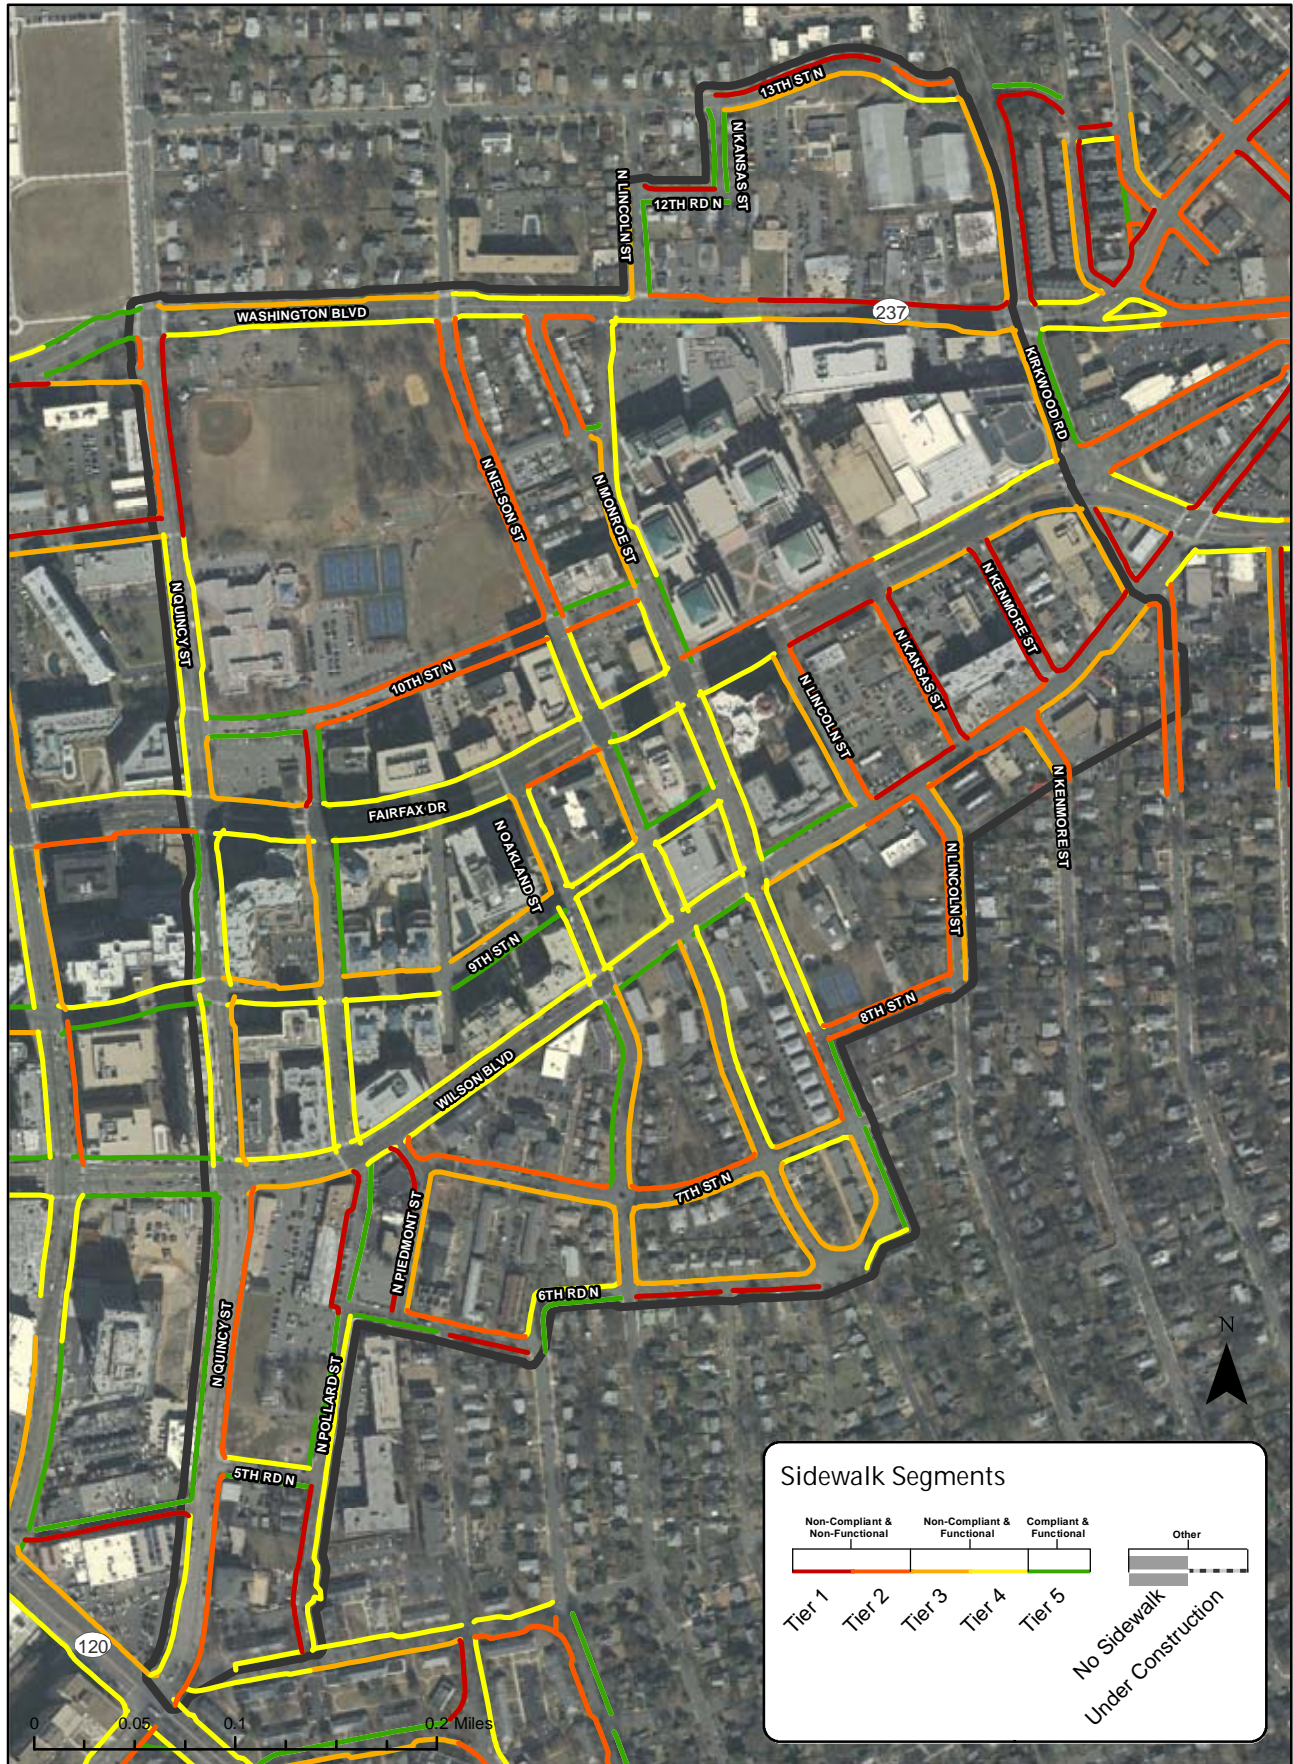
Figure 2-49: Virginia Square Sidewalk Assessment Summary Map

Figure 2-49 is a map of the sidewalk segments in Virginia Square according to the five-tier system. The segments in the eastern part of the TOD, particularly Lincoln Street, Kansas Street, and Kenmore Street, are Tier 1 or Tier 2, meaning these segments are both non-functional and non-compliant and require repair to become usable for those with mobility impairments. Most of the sidewalk segments in the central part of Virginia Square are Tier 4 and Tier 5.

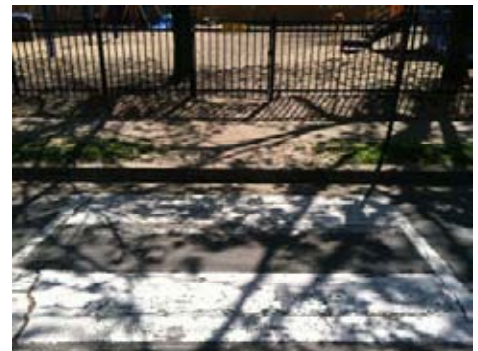
**Figure 2-51: Tier 1 Intersection Segment**

Like curb ramps and the sidewalk segments, the Tier 1 intersection segments are those most in need of repair or reconstruction. Intersection segments in this tier present major barriers to those with limited mobility. Tier 1 intersection segments have multiple missing curb ramps and/or at least one obstruction. Obstructions impede travel by reducing the width of the walk path to less than 36 inches. Similarly, curbs without curb ramps are in effect obstructions, as persons with disabilities are unable to traverse the elevation change between the street and sidewalk. Figure 2-51 is an example of a Tier 1 intersection segment with an obstruction. From a total of 890 surveyed intersection segments within the study area, 33 (3.7%) are Tier 1.

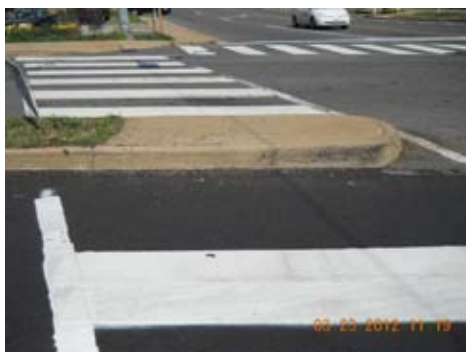
**Figure 2-52: Obstruction  
Example 1**

**Intersection Segment Obstructed:** Intersection obstructions present major barriers to persons in wheelchairs and those with limited mobility. Obstructions include medians, traffic light poles, traffic sign poles, and landscaping. Two percent of intersection segments (20 of 890, not including 11 under construction) have an obstruction, primarily occurring in Clarendon. No segments have multiple obstructions. Figures 2-52 and 2-53 provide examples of obstructions located in Court House on 10<sup>th</sup> street and Barton Street, respectively.

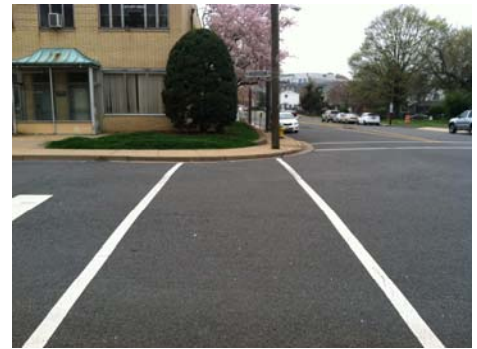
Figure 2-55: Tier 2 Intersection

Tier 2 includes intersection segments with one missing curb ramp, yet the intersection design allows individuals to navigate from one point to another, although not along the most direct route. Figure 2-55 is an example of a Tier 2 intersection leading to a missing curb ramp. In the Study Area, 86 intersections are classified as Tier 2, or about 10% of all intersection segments surveyed.

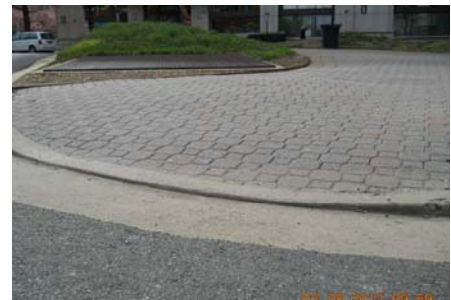
Figure 2-56: Tier 3 Intersection with a vertical change

Tier 3 represents intersection segments that do not meet one or more of the Access Board's or MUTCD guidelines but remain functional, or accessible, for a majority of persons with disabilities. This category includes intersection segments that contain an above average number of compliance issues, and do not fall within Tiers 1, 2, or 5. Compliance issues within this tier include surface gaps and vertical changes. Figure 2-56 displays a Tier 3 intersection segment with a vertical change that may be difficult to navigate for persons in wheelchairs or those with walkers. In instances of manual pedestrian signals, it also includes segments in which the pedestrian button(s) is not accessible from a level 30 by 48 inch space, or is mounted six inches or more below or above 42 inches. Figure 2-57 is an example of a pedestrian push button that is located on a steep slope. When a pedestrian refuge island (either a median or a side island) is present in the intersection, the category includes segments that lack refuge island curb ramps, where needed, or lack refuge island truncated domes. Tier 3 contains 54 out of 890 intersection segments surveyed (6.1%).

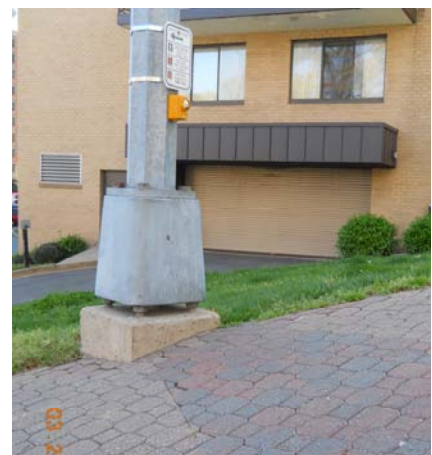
Figure 2-57: Tier 3 Intersection with a difficult-to-access pedestrian button due to slope of sidewalk

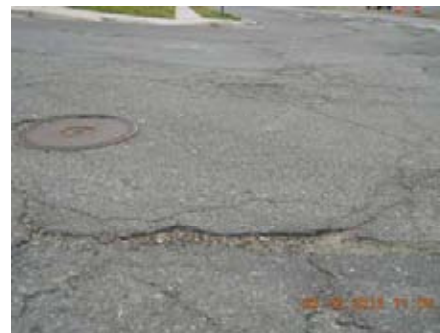
**Figure 2-58: Tier 4 Intersection segment with a gap along the crossing**

Tier 4 contains intersection segments that contain a below average number of compliance issues as discussed in Tier 3, and do not fall within Tiers 1, 2, or 5. Figure 2-58 shows an example of a Tier 4 intersection with a small surface gap. Tier 4 represents 125 out of 890 intersection segments surveyed (14.0%).

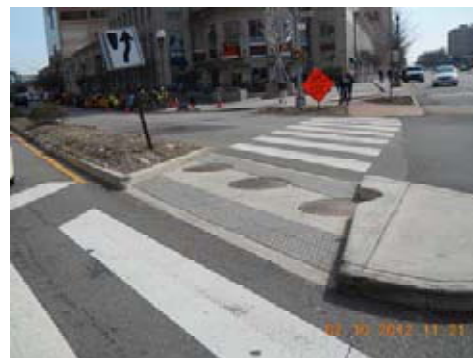
**Figure 2-59: Tier 5 Intersection Segment**

The category Compliant (Tier 5) represents intersection segments that do not have any compliance issues with 2010 Standards. Figure 2-59 shows an example of a Tier 5 intersection segment with an accessible median. The majority of intersection segments in the study area fall in this category (592 of 890 segments, or 66.5%).

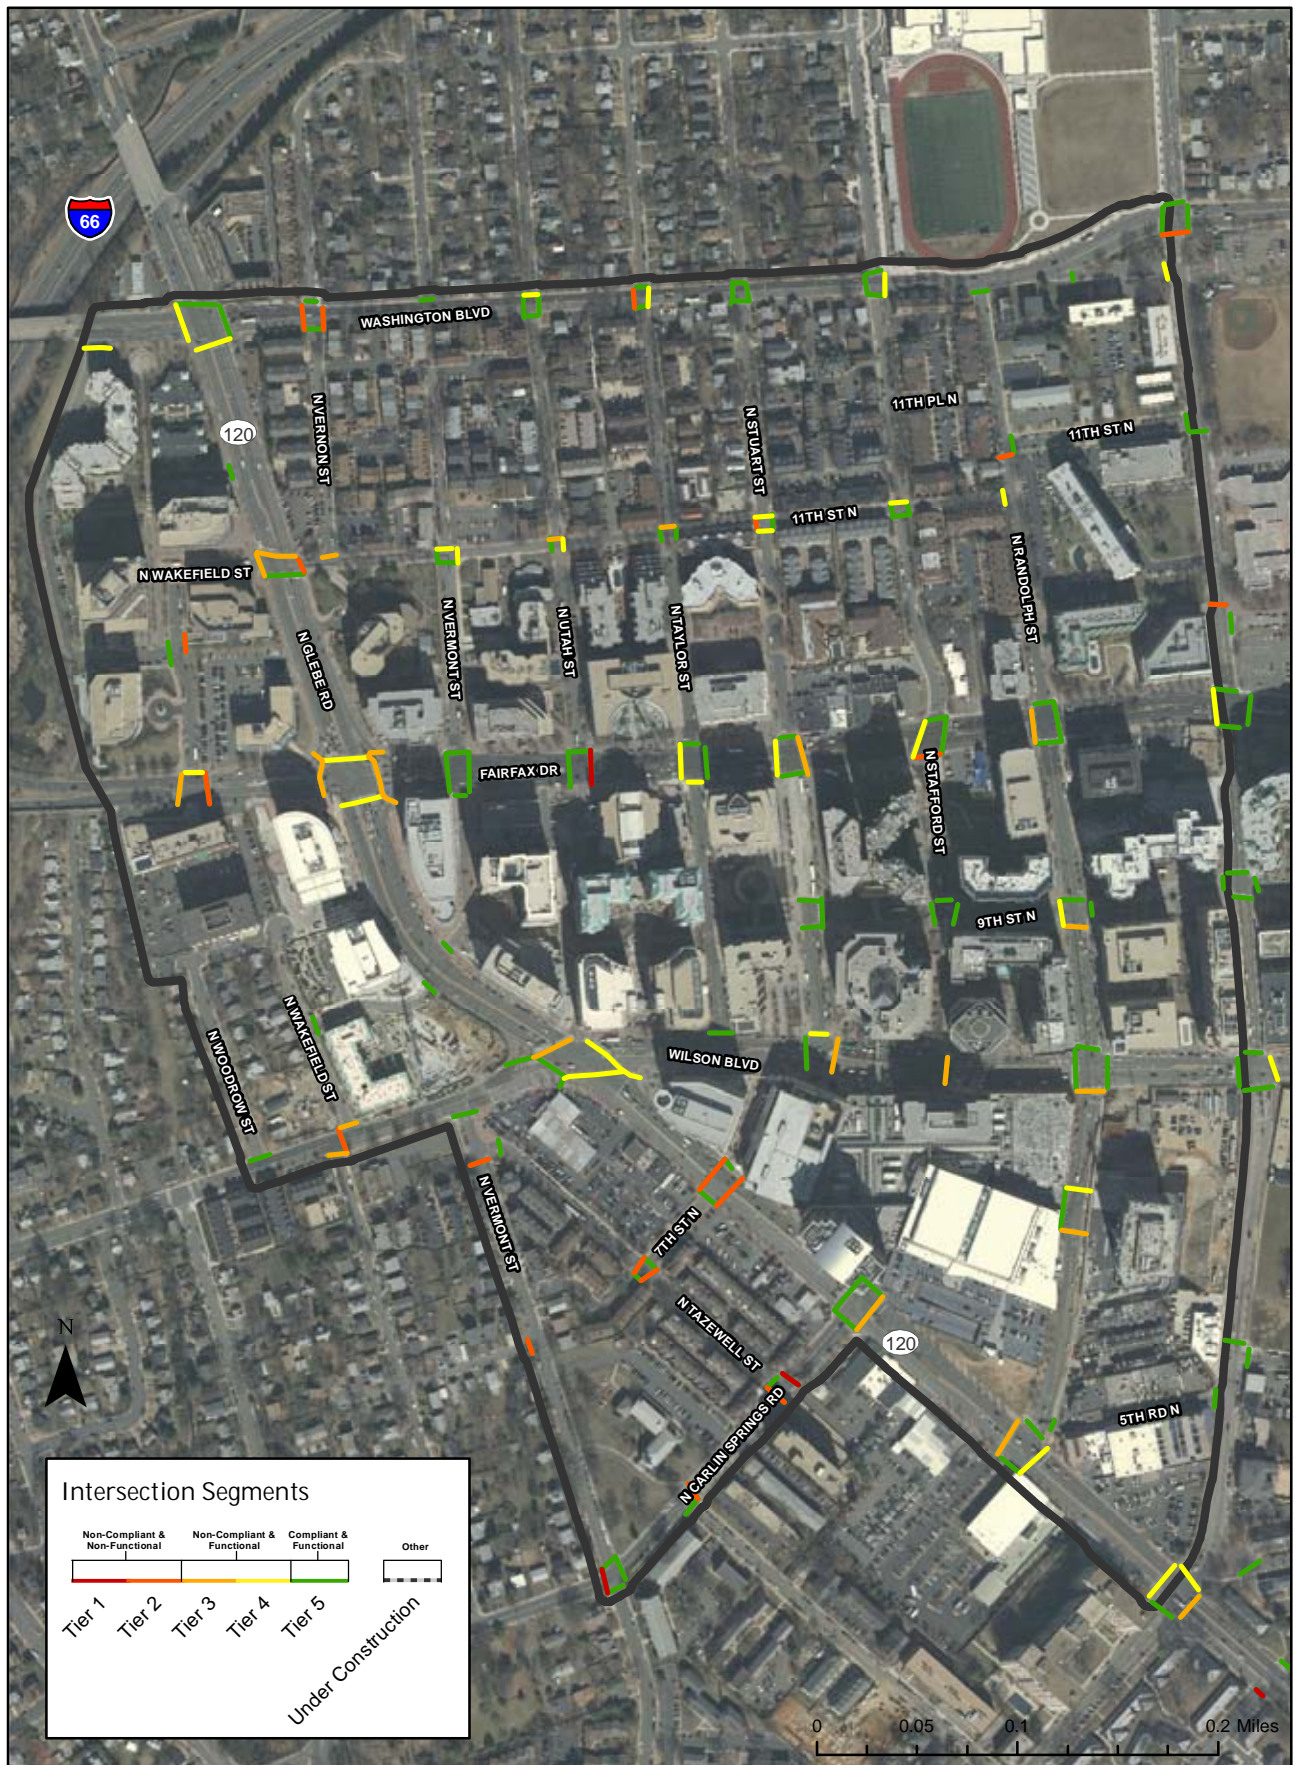
Figure 2-61: Ballston Intersection Segment Assessment Summary Map

As seen in Figure 2-60, almost three-quarters of the intersection segments within the Ballston TOD are either Tier 4 or Tier 5. Ballston has the lowest percentage of segments that is Tier 1 among all TODs, but it also has the lowest percentage of segments without any deficiencies (55% Tier 5). Compliance issues are most prevalent along and to the southwest of Glebe Road. Figure 2-61 displays the locations of the intersection segments within the TOD.

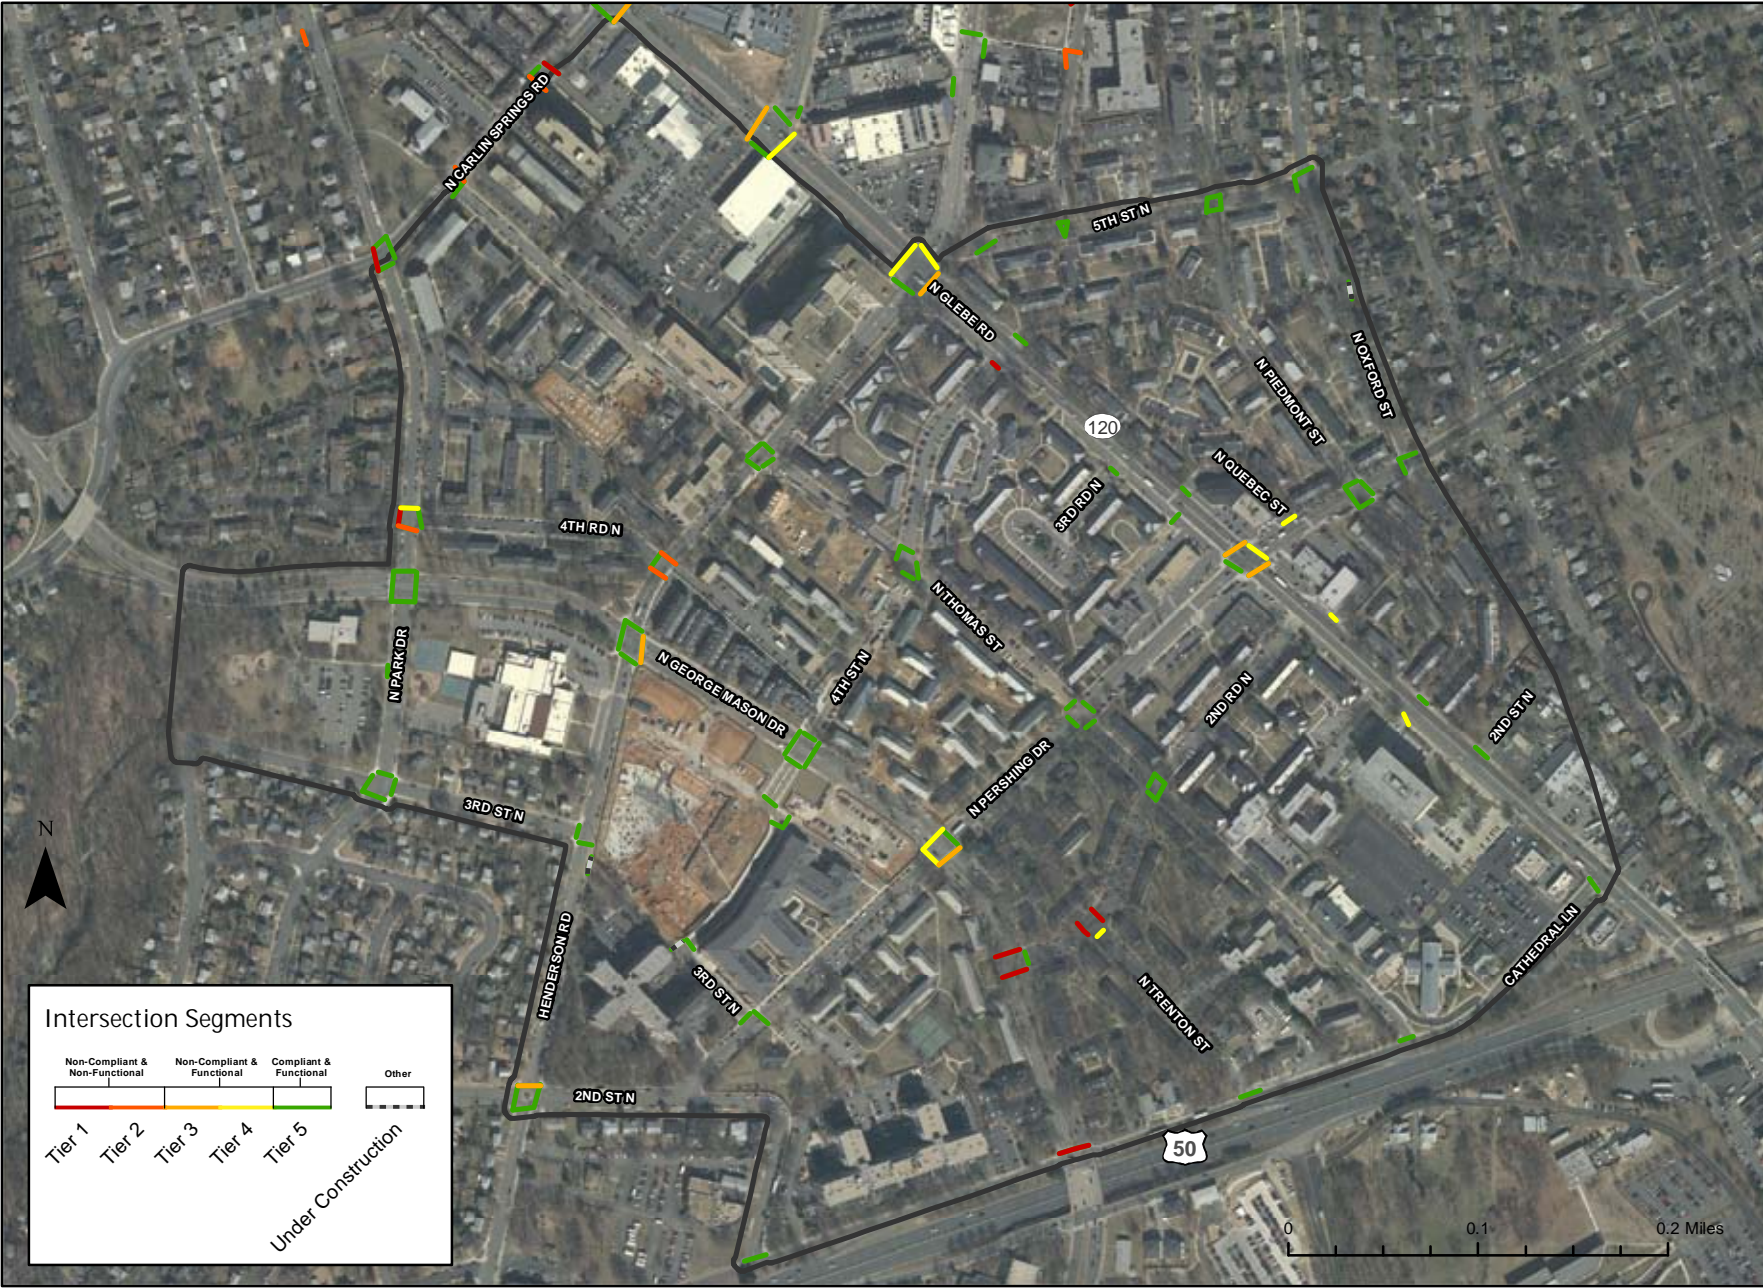
Figure 2-63: Buckingham Intersection Segment Assessment Summary Map

Buckingham contains the second highest percentage of Tier 5 intersection segments as shown in Figure 2-62. However, it also has the greatest percentage of intersection segments in Tier 1. These Tier 1 intersection segments are dispersed, but several are concentrated in the southern section near Arlington Boulevard. Figure 2-63 displays the locations of the intersection segments within this TOD.

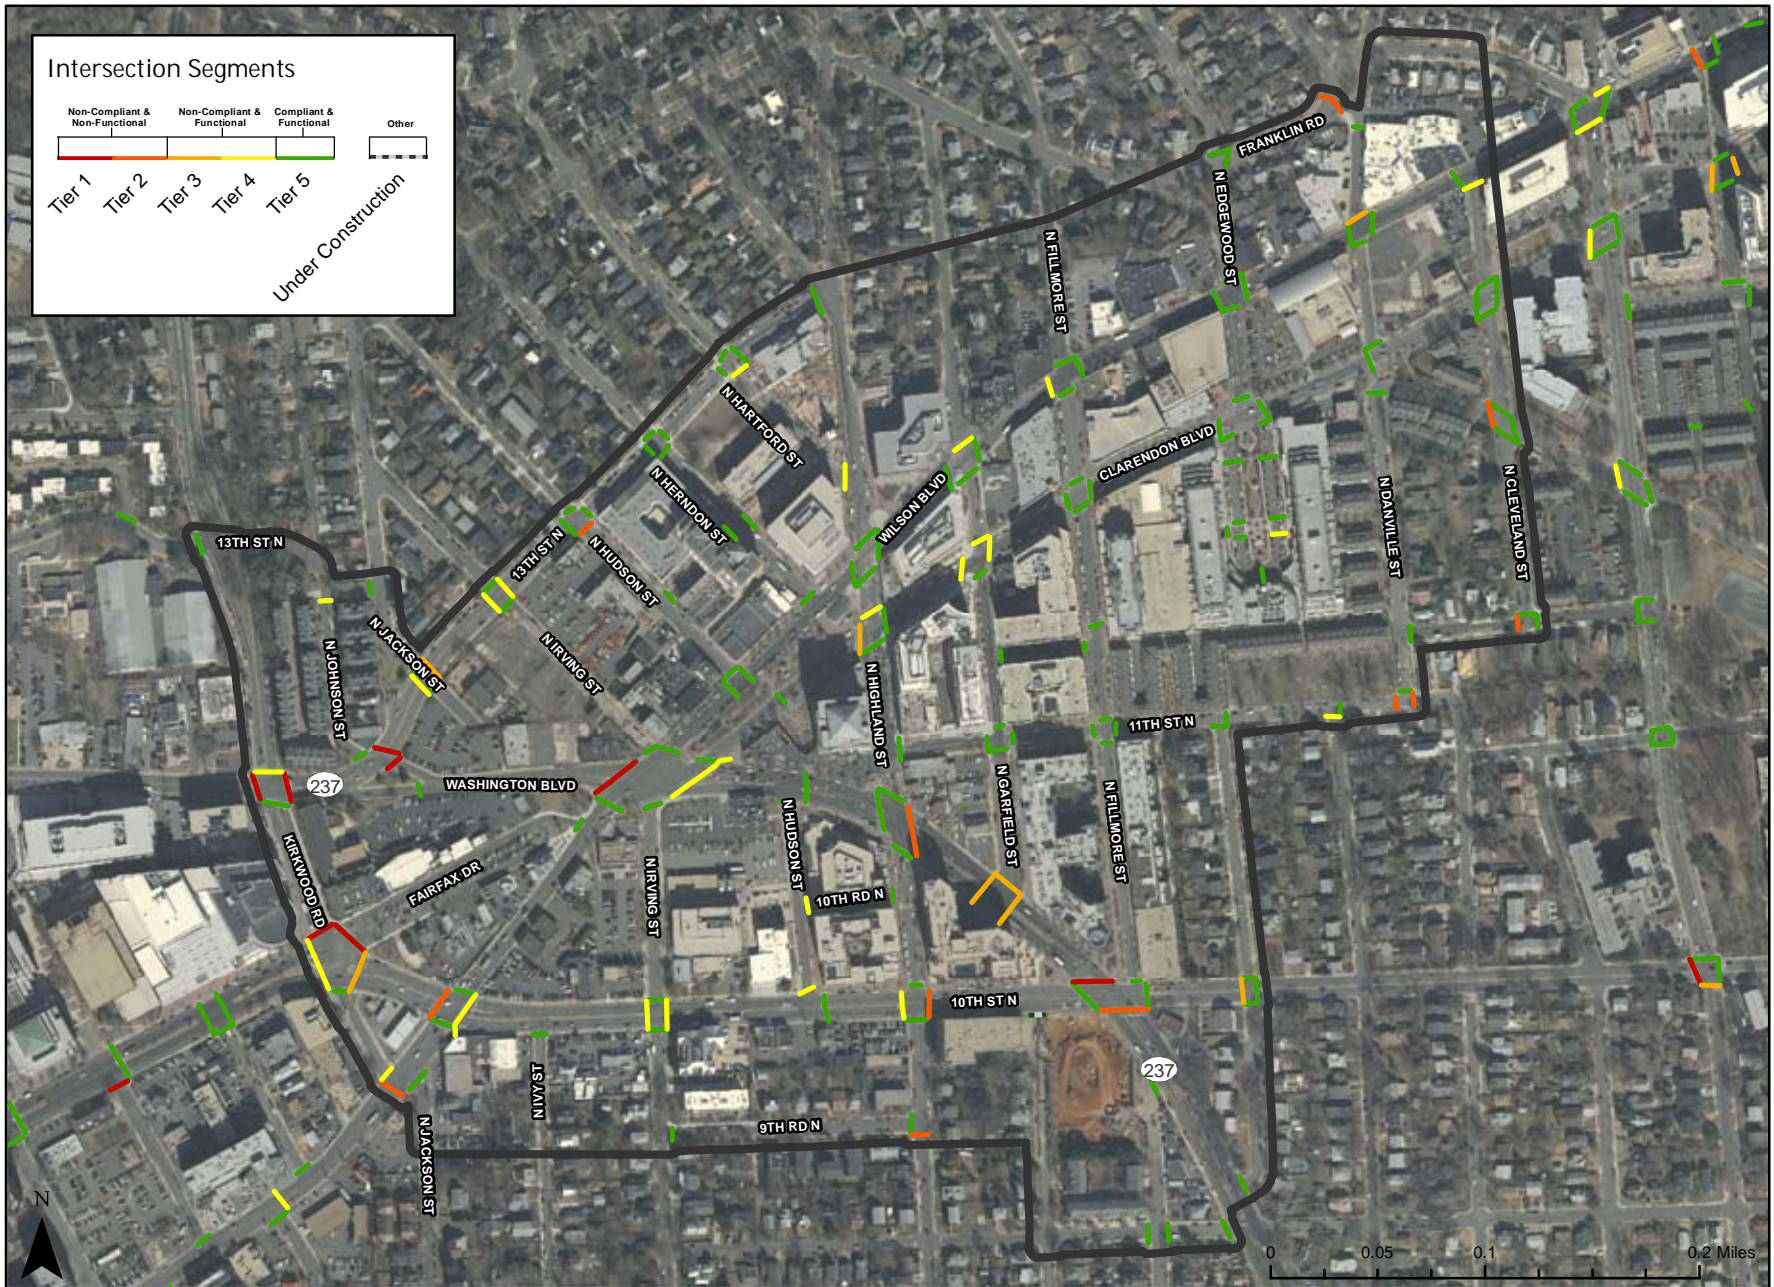
Figure 2-65: Clarendon Intersection Segment Assessment Summary Map

Clarendon features the second highest proportion of Tier 5 intersection segments (71%), as shown in Figure 2-64. These are most notably found along Wilson and Clarendon Boulevards. It also has the smallest percentage of segments with missing curb ramps. Figure 2-65 is a map displaying the location of the intersection segments within Clarendon.
