# Stormwater Best Management Practice (BMP) Performance Assessment in Montgomery County, Maryland

**Rachel Gauza**

Montgomery County

Department of Environmental Protection

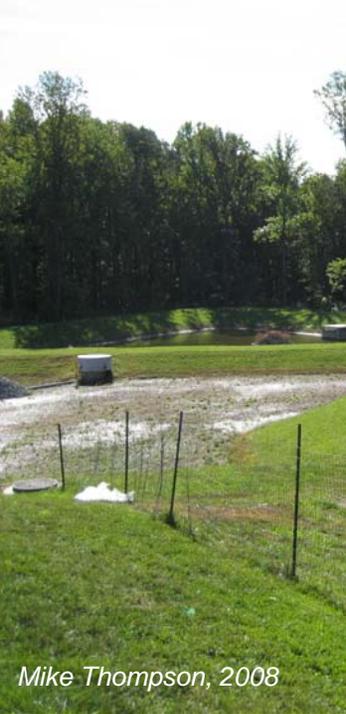
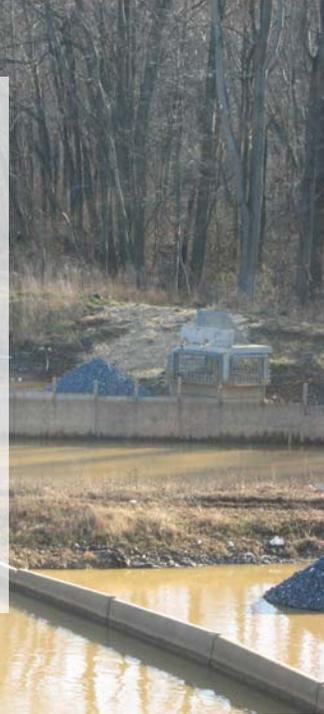
- **S&EC features –**
  - Perforated risers with gravel or filter fiber jackets;
  - Filter fence baffles;
  - Floating skimmers;
  - Dual basins in series;
  - Greater storage volumes; and
  - Utilizing combinations in the form of a treatment train to improve performance.

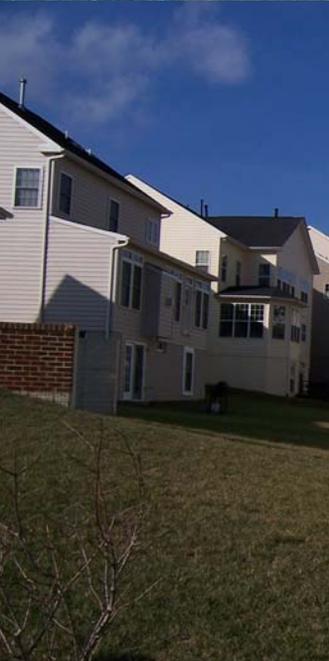
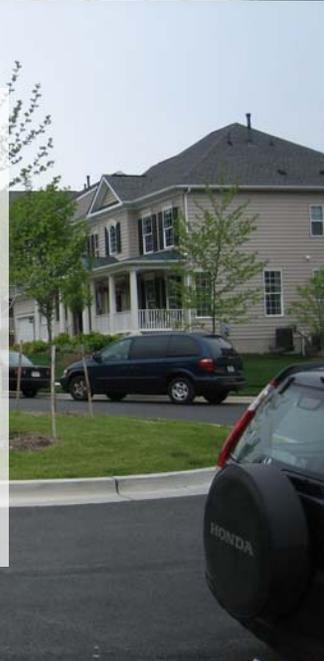
- **Water quality volume –**
  - Treatment of first flush
  - D.A. limit of 3 ac. to a Surface Sand Filter and 1 acre for all other water quality structures.
- **Channel protection storage volume –**
  - One year 24 hour storm
- **Recharge volume**

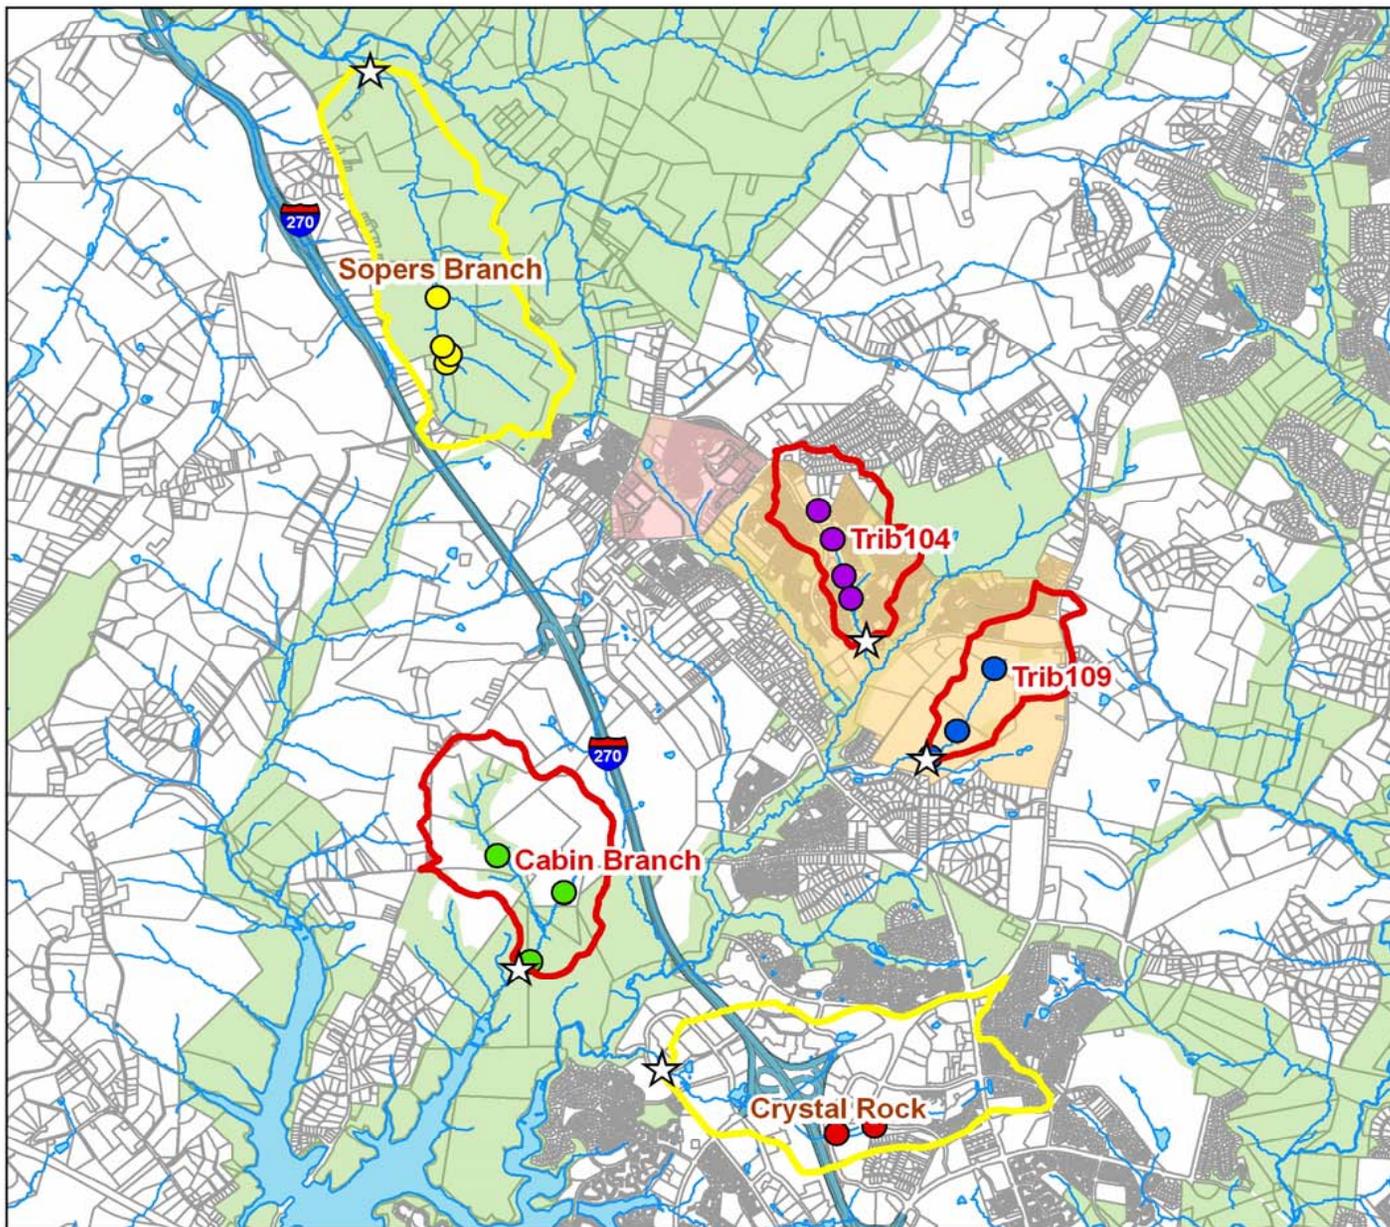
# Clarksburg Study Areas, Biomonitoring, & Geomorphology Stations

## Clarksburg Study Areas

## ☆ Biomonitoring Sites

## Geomorphology Survey Areas

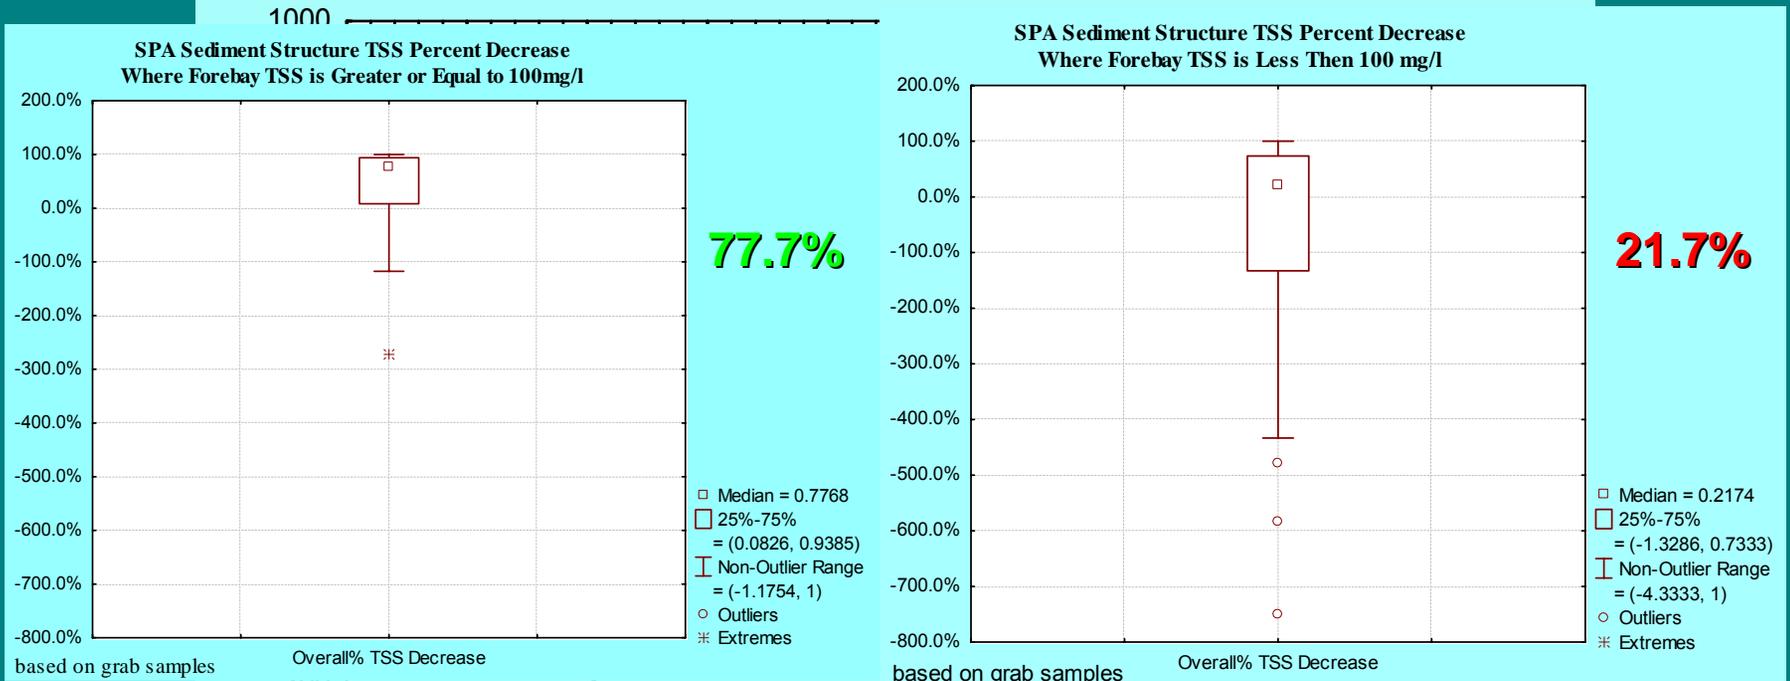
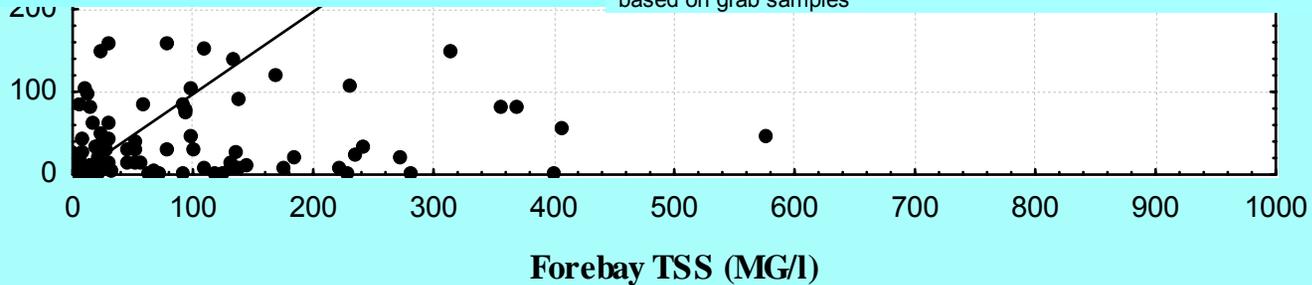
## Forebay and Outfall TSS Concentrations

101 grab samples from 15 structures (2002-2007)

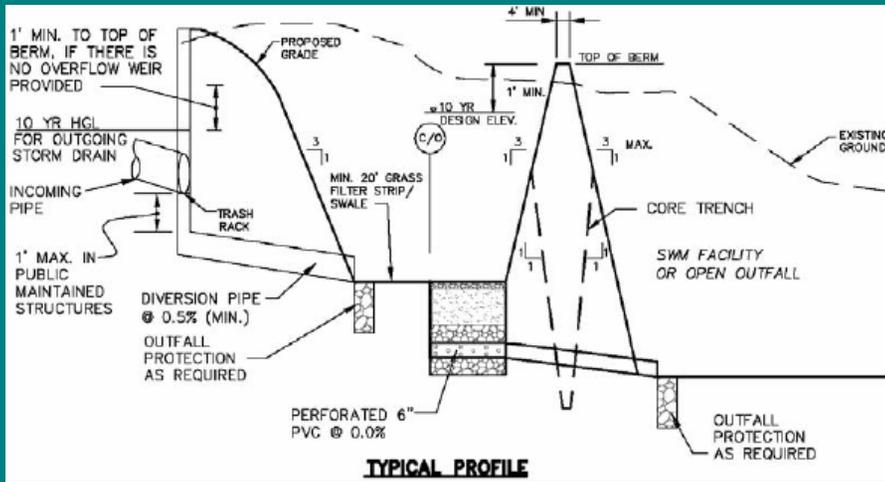
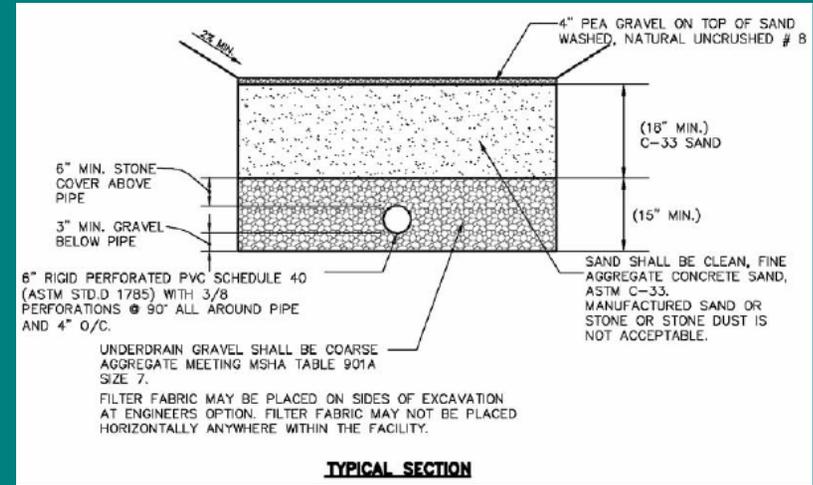
# Surface Sandfilter

- Best-suited for managing first flush
- Recharge area beneath filter medium and underdrain pipe
- Removal efficiencies with reported TSS removal efficiency of 49 to 86%

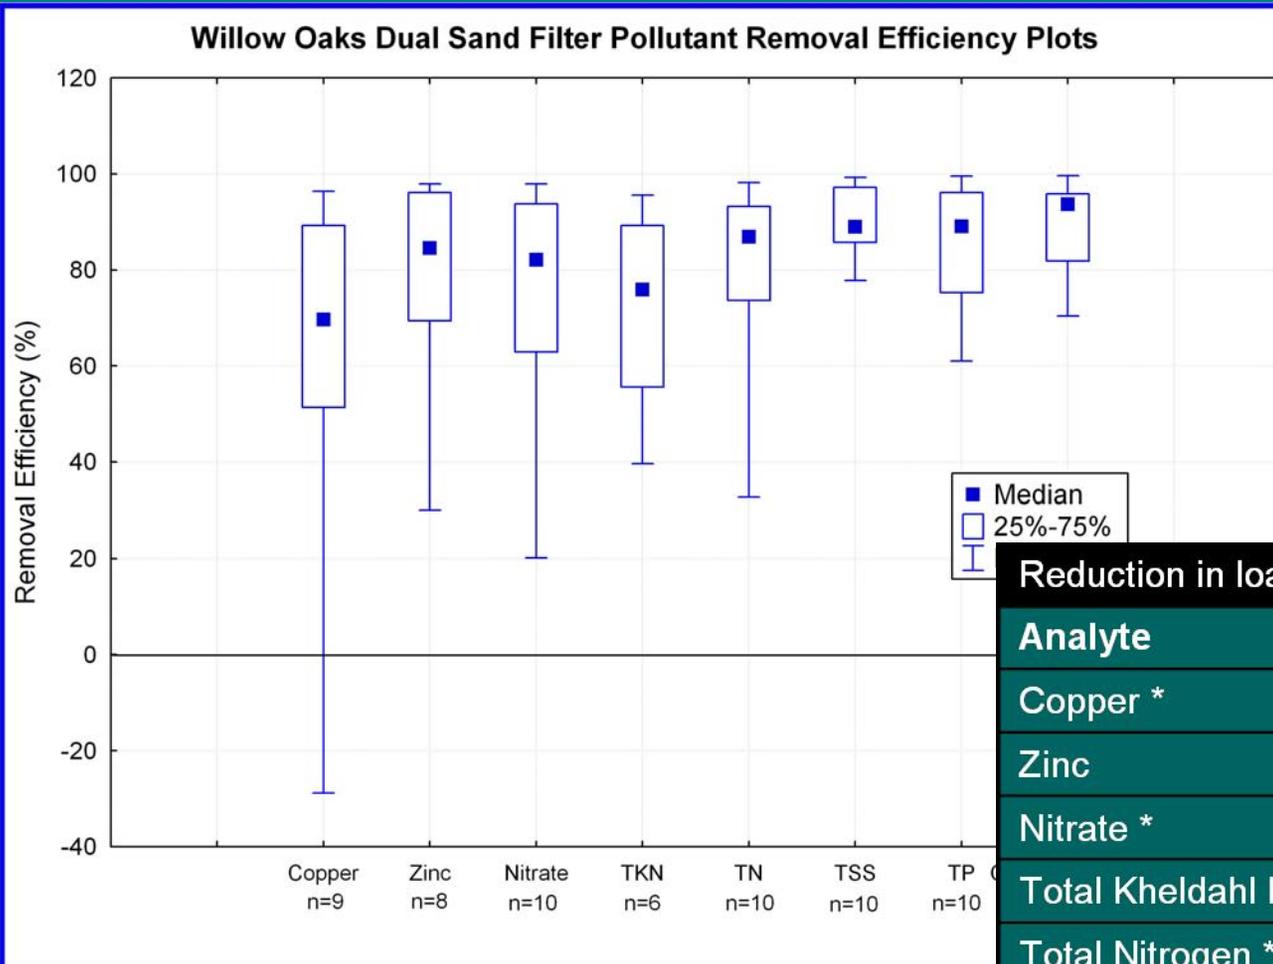
# Willow Oaks Surface Sand Filters

July 2005 –  
March 2008

13 storms

> 62%

## Reduction in loadings for cell 1

Analyte	Ave. Removal
Copper *	84.1%
Zinc	93.4%
Nitrate *	83.6%
Total Kheldahl Nitrogen	82.0%
Total Nitrogen *	87.4%
Total Suspended Solids *	89.1%
Total Phosphorus *	85.4%
Orthophosphate *	80.9%

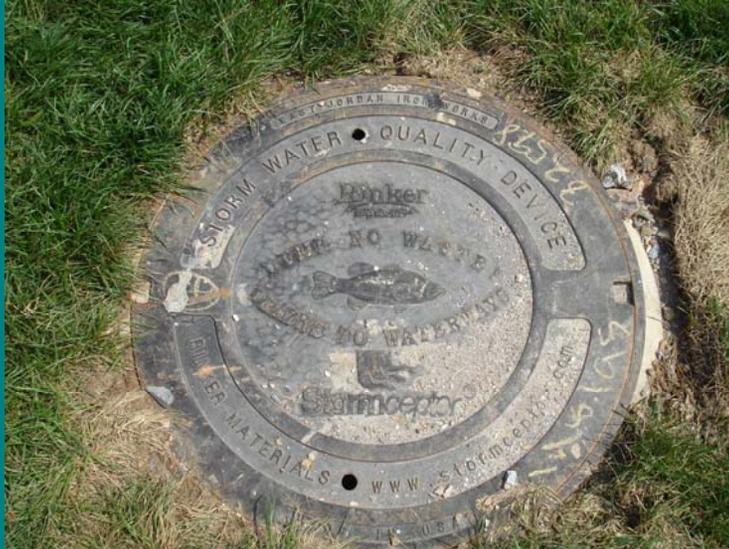
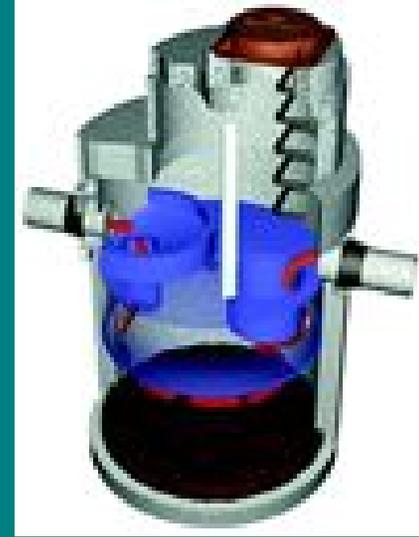
# Stormceptor®

- Hydrodynamic device
- Treats a maximum flow rate and bypasses the remainder of the runoff volume
- Slows incoming stormwater to reduce turbulence which allows oils to rise and sediment to settle
- Variable removal efficiencies of TSS:
  - Manufacturer – **80%**
  - Massachusetts Strategic Environment Technology Partnership – **between 52 and 77%**
  - Center for Watershed Protection – **between 21% and 51.5%**

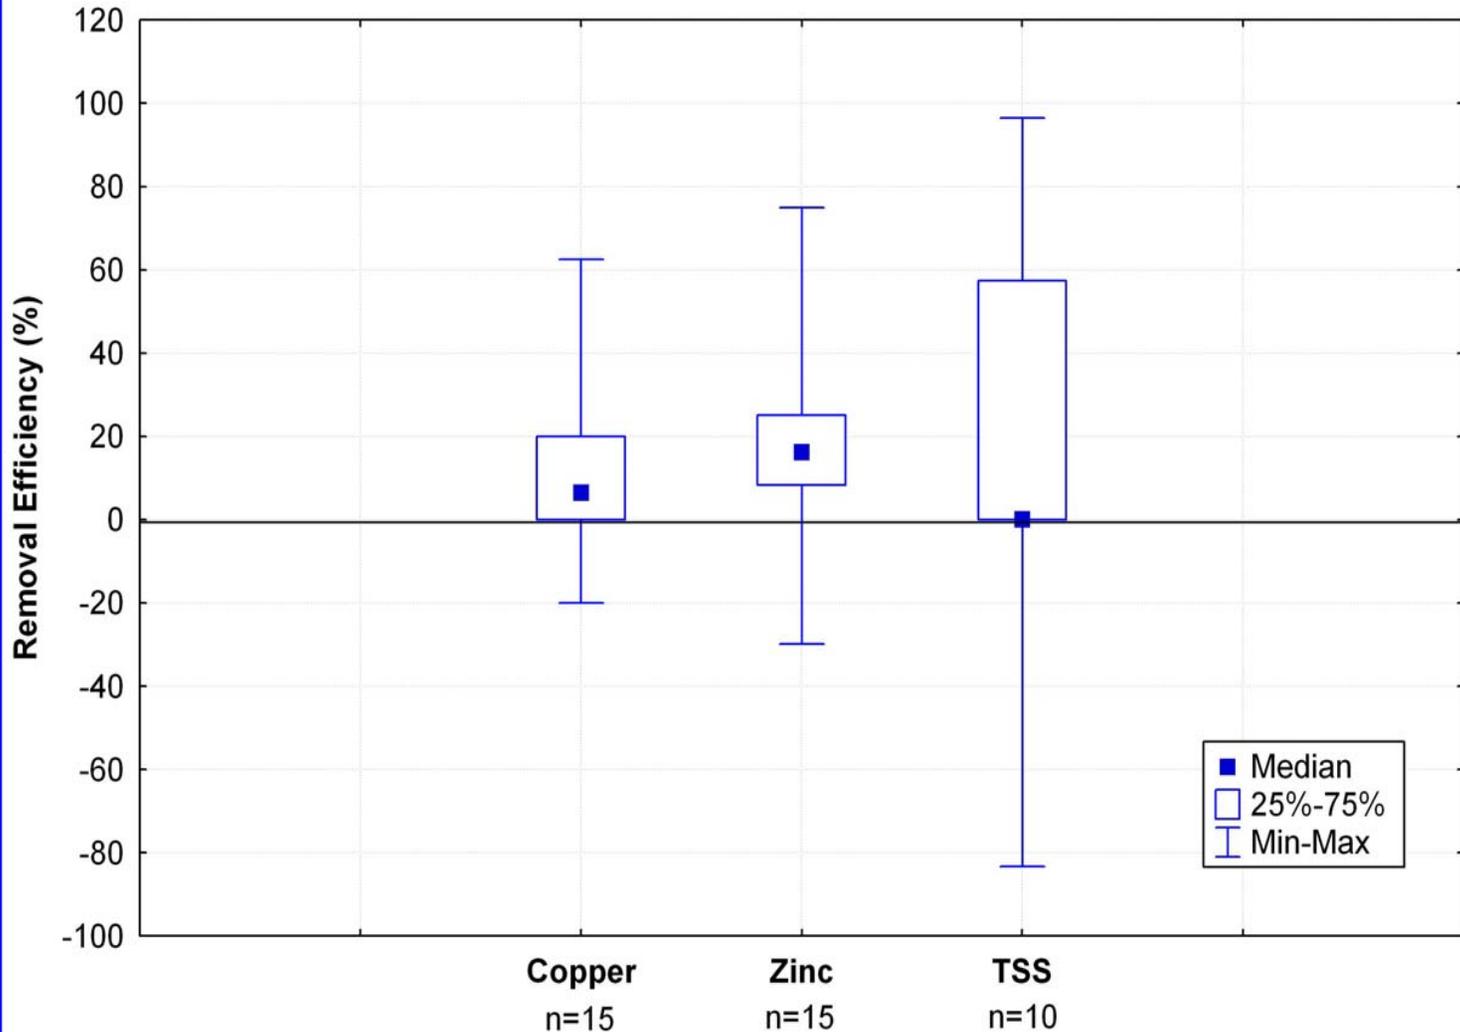
## Cloverly Safeway Stormceptor® Pollutant Removal Efficiency Plots

- ***B.D.L. – Cadmium, Lead***
- ***In vs. out – Not statistically different***
- ***For 13 of the 15 storms (Nov. 2002 – June 2008), the runoff temperatures increased sharply between approx. 3 and 18°F***

BMP efficiencies of structures alone cannot be used to assess BMP effectiveness at protecting water quality.

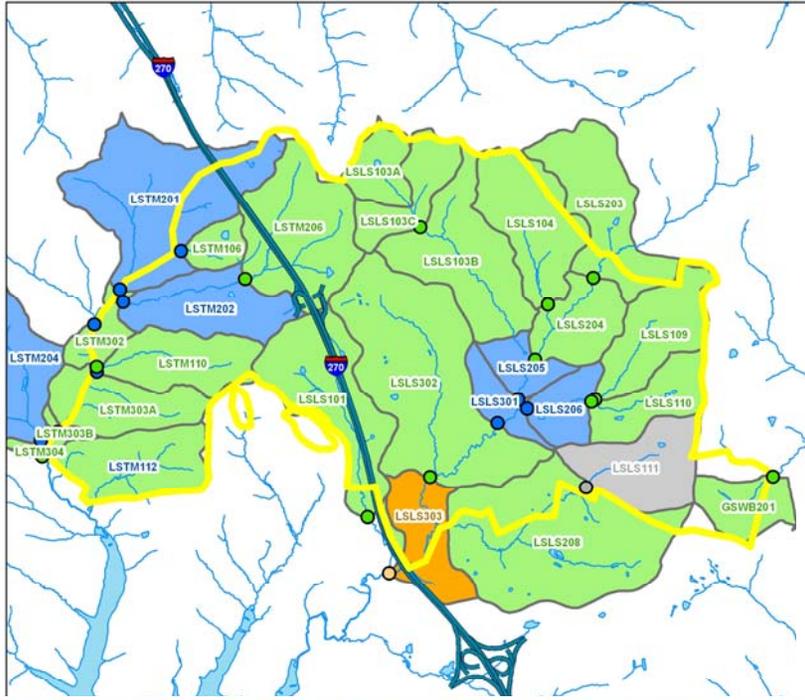
Clarksburg SPA - Average Stream Conditions 1994-1998 (Pre-Development)

- Stream Condition IBI Categories**
- Excellent
  - Good
  - Fair
  - Not Monitored until 1999
  - Streams
  - Clarksburg SPA Boundary

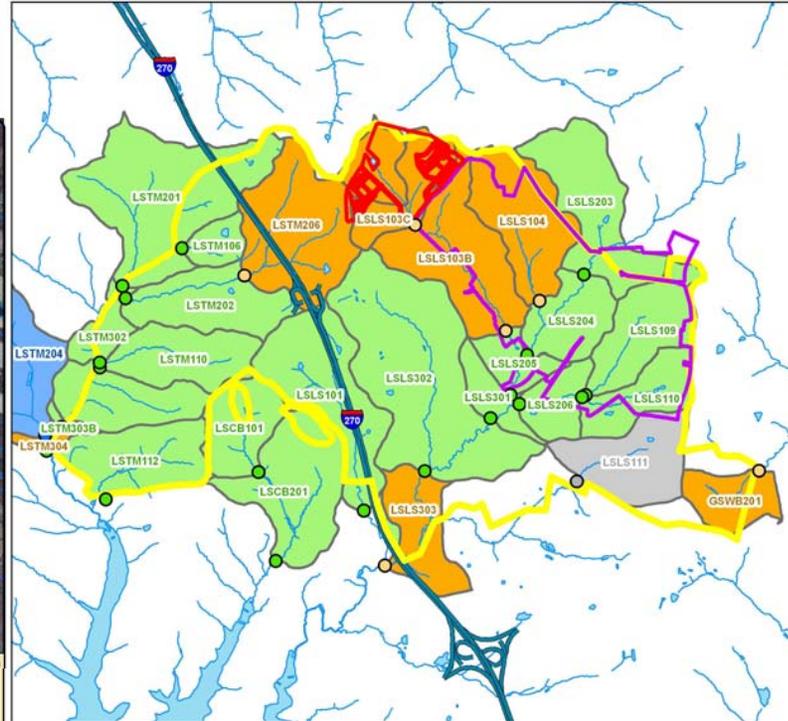
Clarksburg SPA - Average Stream Conditions 2006-2007 (Current)

- Stream Condition IBI Categories**
- Excellent
  - Good
  - Fair
  - Not Monitored since 2000
  - Streams
  - Clarksburg SPA Boundary
  - Clarksburg Town Center
  - Newcut Road Neighborhoods

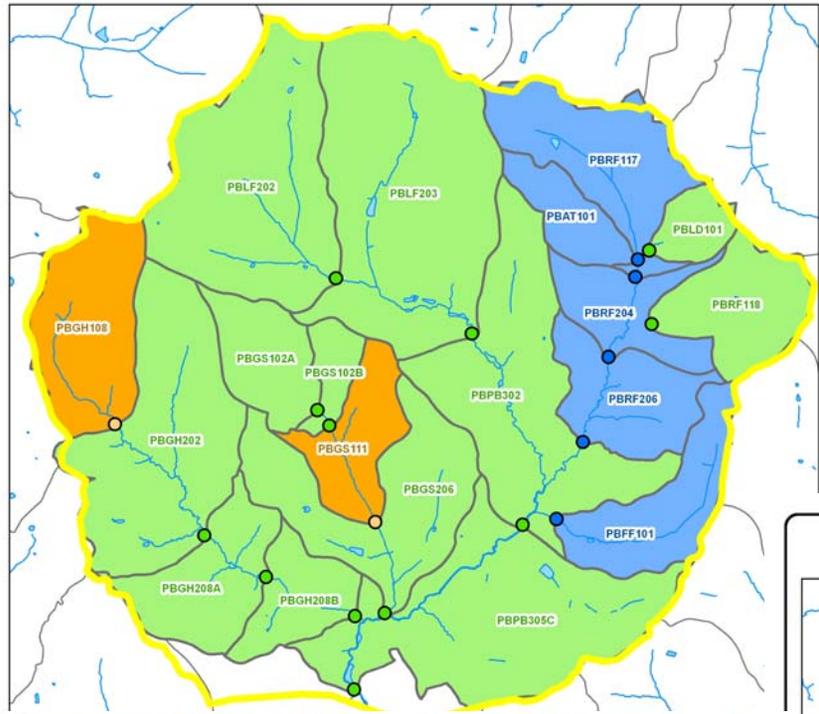
Paint Branch SPA - Average Stream Conditions 1994-1998 (Pre-Development)

**Stream Condition IBI Categories**

- Excellent
- Good
- Fair
- Streams
- Paint Branch SPA Boundary

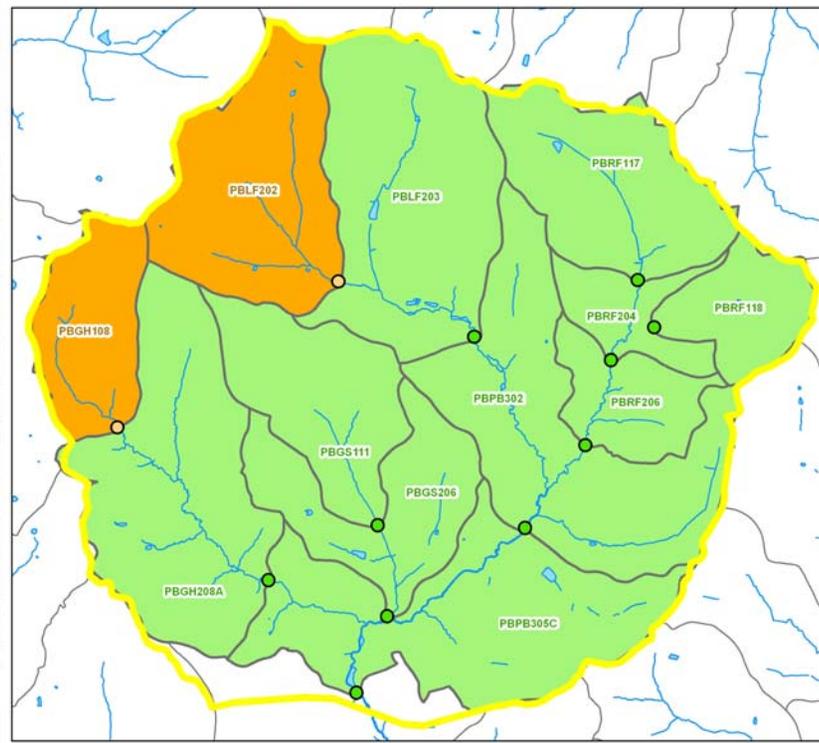
Paint Branch SPA - Average Stream Conditions 2006-2007 (Current)

**Stream Condition IBI Categories**

- Good
- Fair
- Poor
- Streams
- Paint Branch SPA Boundary

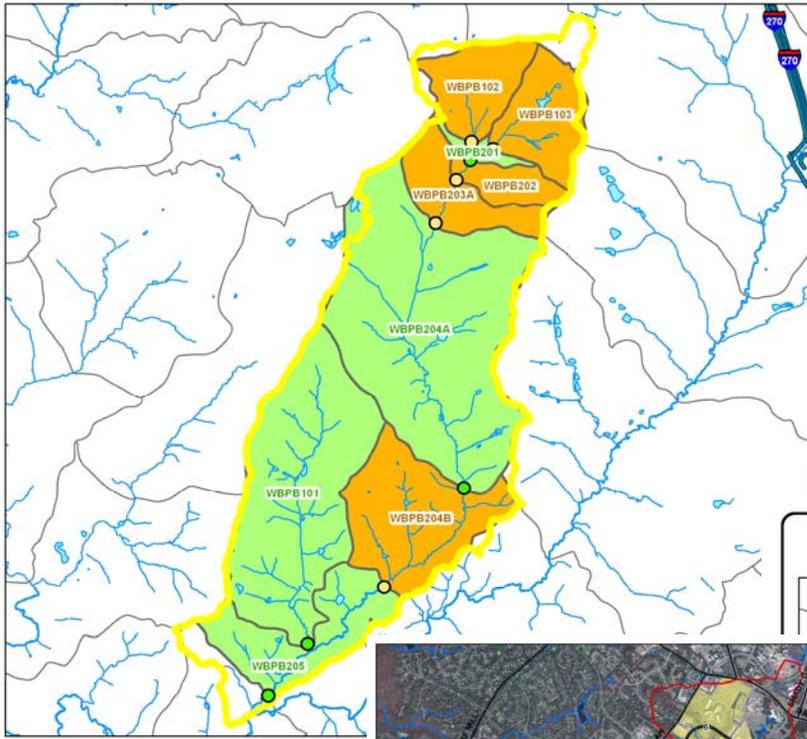
Piney Branch SPA - Average Stream Conditions 1995-1997 (Pre-Development)

Stream Condition IBI Categories

- Good
- Fair
- Streams
- Piney Branch SPA Boundary

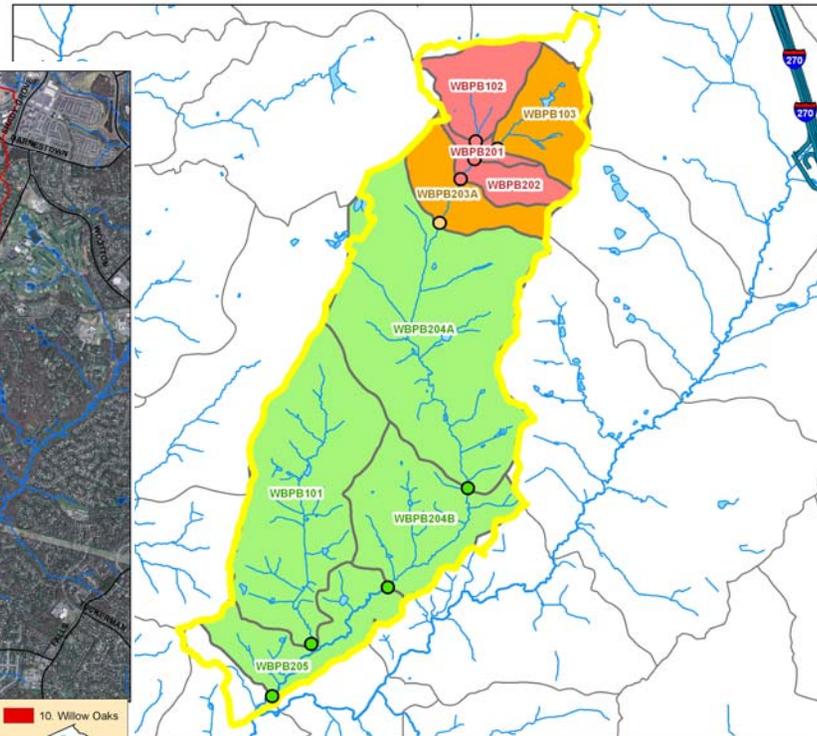
Piney Branch SPA - Average Stream Conditions 2006-2007 (Current)

Stream Condition IBI Categories

- Good
- Fair
- Poor
- Streams
- Piney Branch SPA Boundary

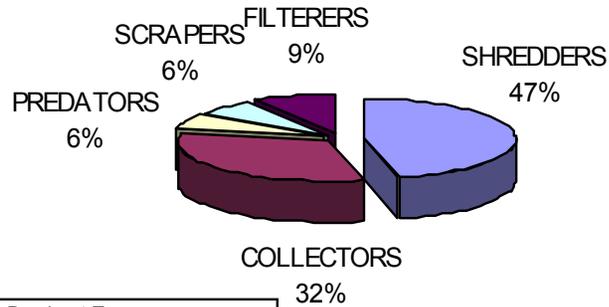
### Functional Feeding Groups; Clarksburg Pre-Construction (1996-2000)

**Amphinemura sp.** (Shredder) = 43%  
**Chironomidae** (Collector) = 20%  
 N=35  
 Total # of Stations = 9

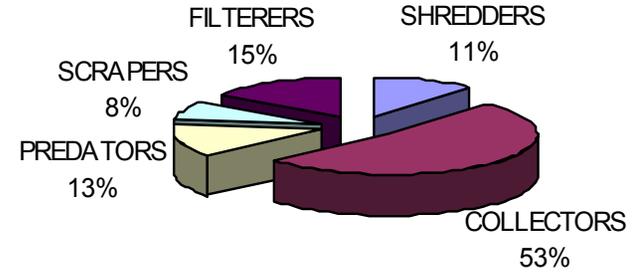
### Functional Feeding Groups; Clarksburg Through Construction (2003-2007)

**Chironomidae** (Collector) = 52%  
**Amphinemura sp.** (Shredder) = 8%  
 N = 37  
 Total # of Stations = 9

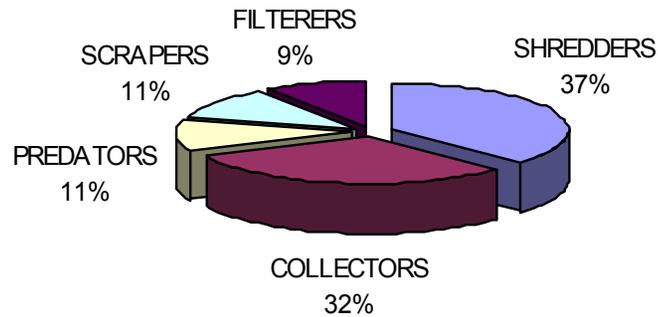
### Functional Feeding Groups; Clarksburg Control (1996-2000)

**Amphinemura sp.** (Shredder) = 33%  
**Chironomidae** (Collector) = 21%  
 N=25  
 Total # of Stations = 8

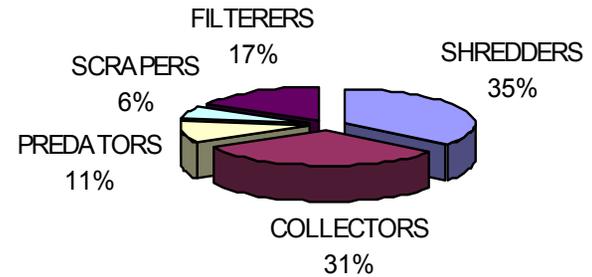
### Functional Feeding Groups; Clarksburg Control (2003-2007)

**Chironomidae** (Collector) = 33%  
**Amphinemura sp.** (Shredder) = 32%  
 N = 27  
 Total # of Stations = 8

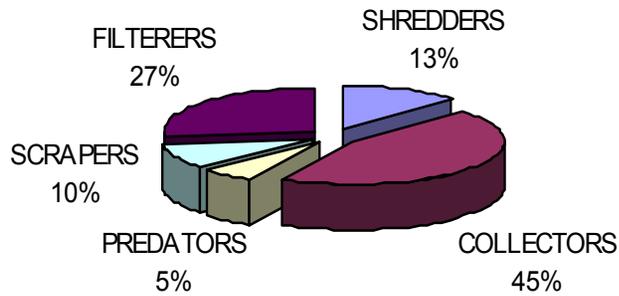
**Functional Feeding Groups; Paint Branch  
Pre-Construction (1995-1999)**

**Chironomidae** (Collector) = 20%  
**Ephemerella sp.** (Collector) = 17%  
 N=23  
 Total # of Stations = 6

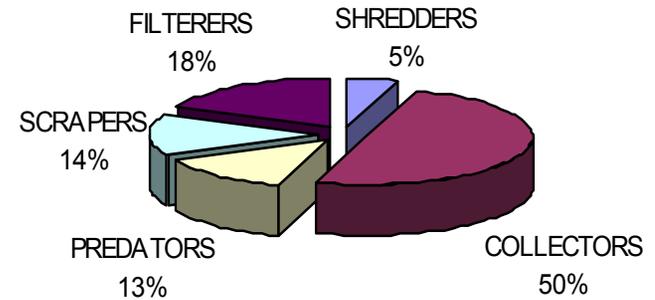
**Functional Feeding Groups; Paint Branch  
Through Construction (2001-2006)**

**Chironomidae** (Collector) = 44%  
**Simulium sp.** (Filterer) = 5%  
 N=36  
 Total # of Stations = 6

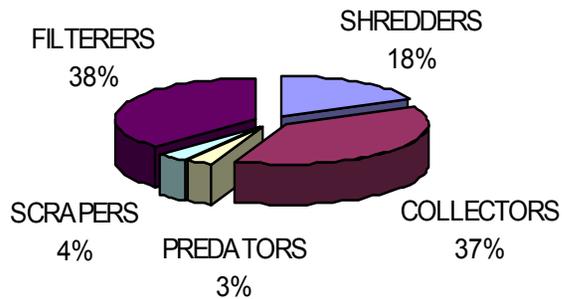
**Functional Feeding Groups; Paint Branch  
Control (1994-1999)**

**Chironomidae** (Collector) = 20%  
**Ephemerella sp.** (Collector) = 15%  
 N=19  
 Total # of Stations = 4

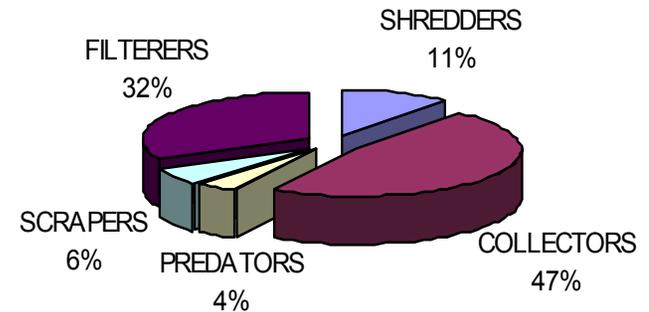
**Functional Feeding Groups; Paint Branch  
Control (2001-2006)**

**Chironomidae** (Collector) = 38%  
**Dolophilodes sp.** (Filterer) = 19%  
 N=26  
 Total # of Stations = 4

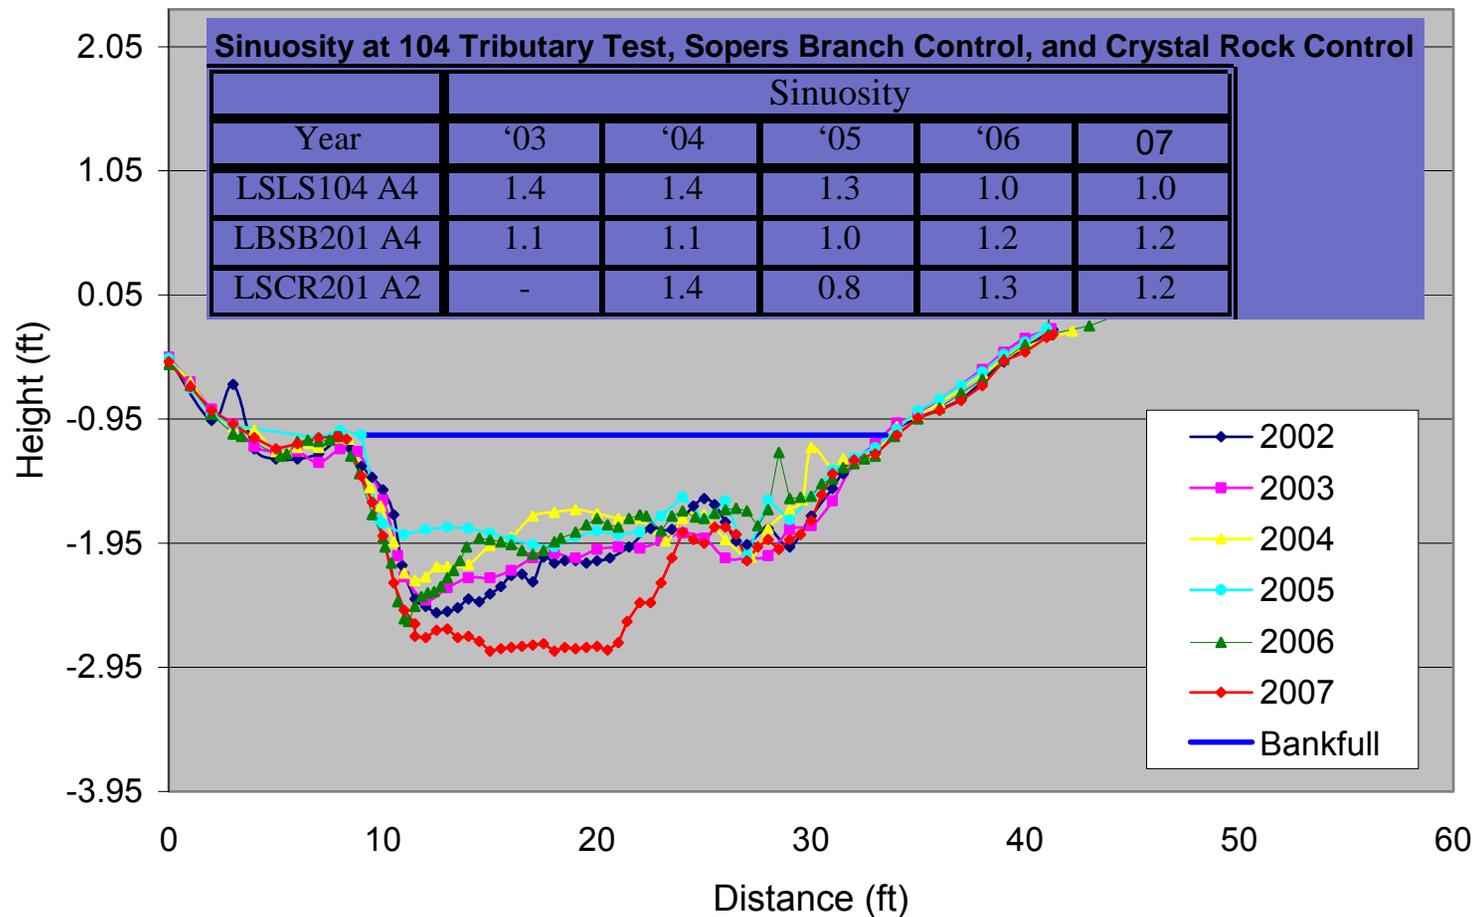
Test Location (Area 4, cross section 1) (Most downstream)

## Little Seneca 104 Tributary - Newcut Road Neighborhood
